REMOVAL OF AN UNLAWFUL SEAWALL FROM A SYDNEY OPEN COAST BEACH - THE STEPS TO SUCCESS

Peter Horton¹ and Daylan Cameron²

¹ Principal Engineer (Coastal & Maritime), Haskoning Australia, North Sydney, NSW

² Senior Environment Officer (Natural Hazards), Warringah Council, Dee Why, NSW

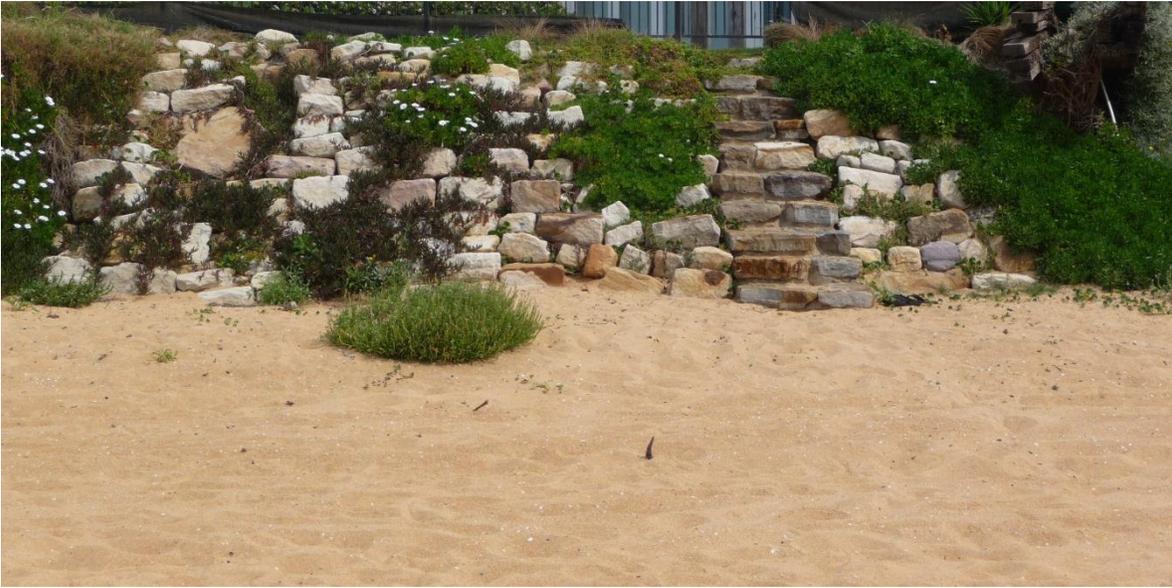
A photograph of the illegal seawall after its construction is provided in Figure 1. This "seawall" comprised sandstone rocks with a typical dimension of about 350mm, with rock masses varying between about 30kg and 120kg. The rocks had been placed in an approximate brickwork pattern at a slope of between 45° and 60° from the horizontal, and built around sandstone steps (average dimension about 400mm) fixed in position with cement mortar at a slope of about 30°. The seawall had a crest level of about 6.1m AHD and toe level of about 3.5m AHD.

Given the relatively low rock mass and relatively high toe level, the illegal seawall was expected to fail in a relatively frequent storm event (eg 10 year average recurrence interval or more frequent). To withstand a 100 year average recurrence interval (ARI) storm with beach scour levels in the order of -1m AHD, the toe level of the structure would have had to have been at least 4.5m lower. Furthermore, to resist 100 year ARI wave action, sandstone rock masses would have to be in the order of 3 to 10 tonnes, about 100 times larger than in the illegal seawall.

Figure 1: Illegal seawall about 2 years after construction, in March 2010

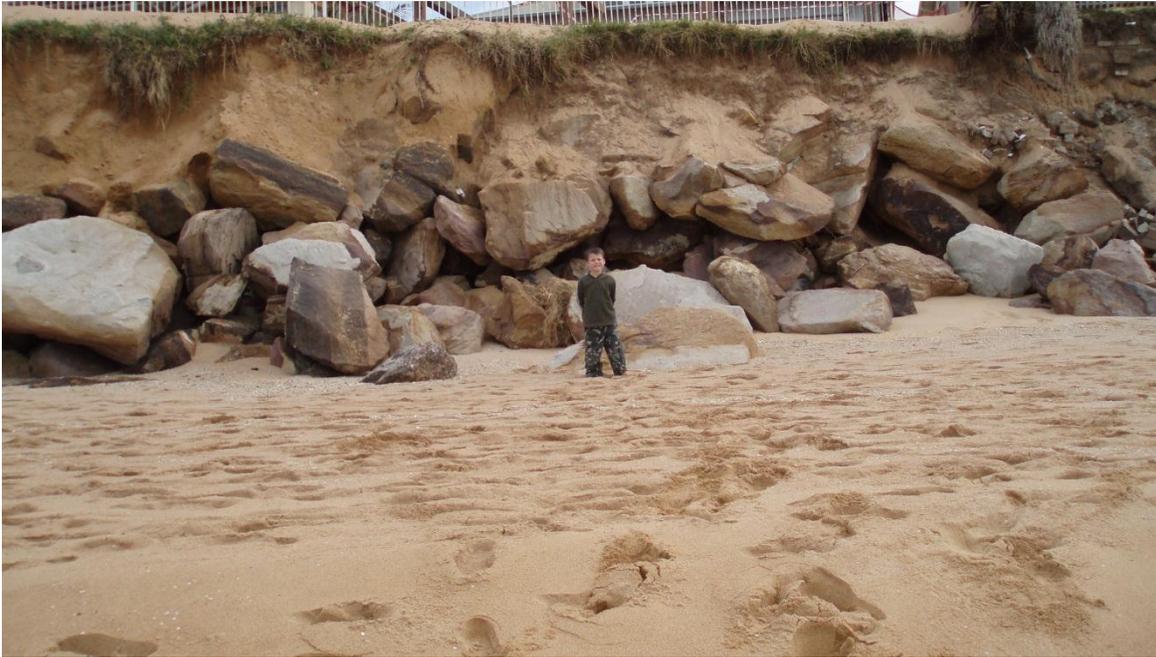
Prior to construction of the illegal seawall, coastal storms in June and July 2007 exposed previous protection works that had been undertaken at the property, as visible in Figure 2. The rocks comprising these historical works (typical dimension about 1m to 1.5m and typical mass several tonnes) are much larger than the rocks comprising the illegal wall, and extend several metres lower. The historical works are located immediately landward of where the illegal seawall was constructed.

Given the substantial nature of the historical protective works, it is evident that the undersized and poorly founded illegal seawall was essentially providing no significant protective function against wave action and beach erosion beyond the historical works alone.

Figure 2: Historical protection works exposed at subject property in July 2007

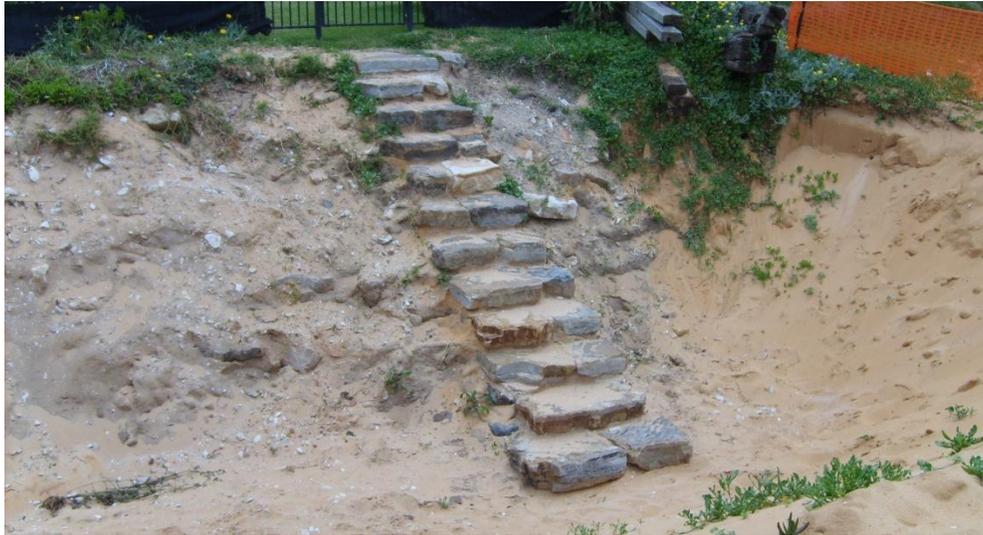
The illegal seawall was initially removed by the owner in November 2011, as depicted in Figure 3. Inspection indicated that, as evident, numerous small rocks remained in the dune, prompting a request for further removal of rocks.

Figure 3: View after initial removal of illegal seawall, November 2011
