CASE STUDIES IN DAMAGE AND REPAIR STRATEGIES FOR TRAINING WALLS AND BREAKWATERS ON THE NSW COASTLINE POST-JUNE 2016 STORM

Abstract

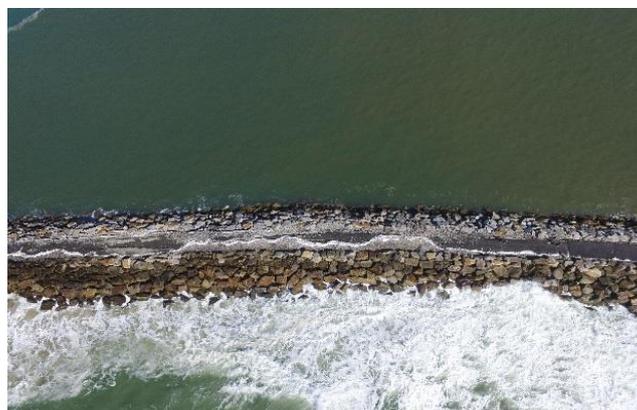
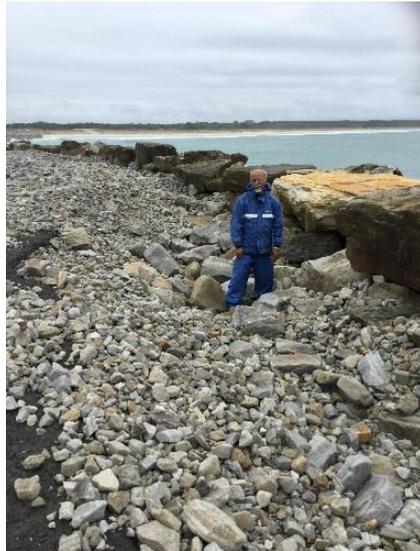
**Figure 5b Clarence north training wall crest damage post-June 2016 storm
(drone photo courtesy Dol – LaW)**

Figure 5c Clarence north training wall crest post-June 2016 storm – closer view of crest damage

The training wall at Narooma north is an example where the existing berm (Figure 11) on the ocean side is likely to have prevented serious crest damage, unlike the damage that occurred along 400 m of crest on the ocean side of the Clarence north training wall (Figures 5b and 5c) and the crest damage to the Moruya north training wall (Figures 9a and 9b).

- The NE-E direction of the storm resulted in extensive crest and head damage to the Clarence north training wall.
- In instances where severe head damage was observed such as Clarence north, Clarence south and Port Macquarie north training walls, rock placement (Figures 12b and 12c) with appropriate longer axis providing higher Kd values (>4) as utilised in CERC (1987) may have resulted in less damage.

- Use of improved repair machinery may have resulted in smoother faced batters on the ocean side of the training wall which in turn may have resulted in higher volumes of runup and subsequent crest damage as viewed at the Clarence north training wall.

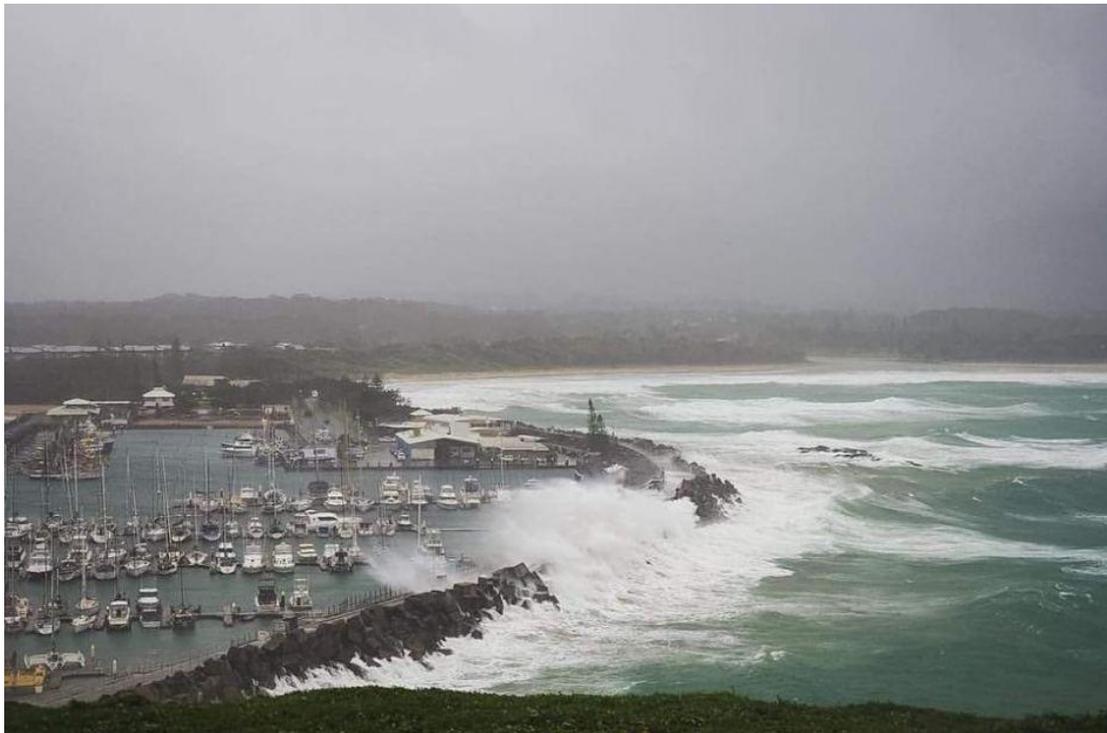
Figure 6a Coffs Harbour north breakwater storm, June 2016

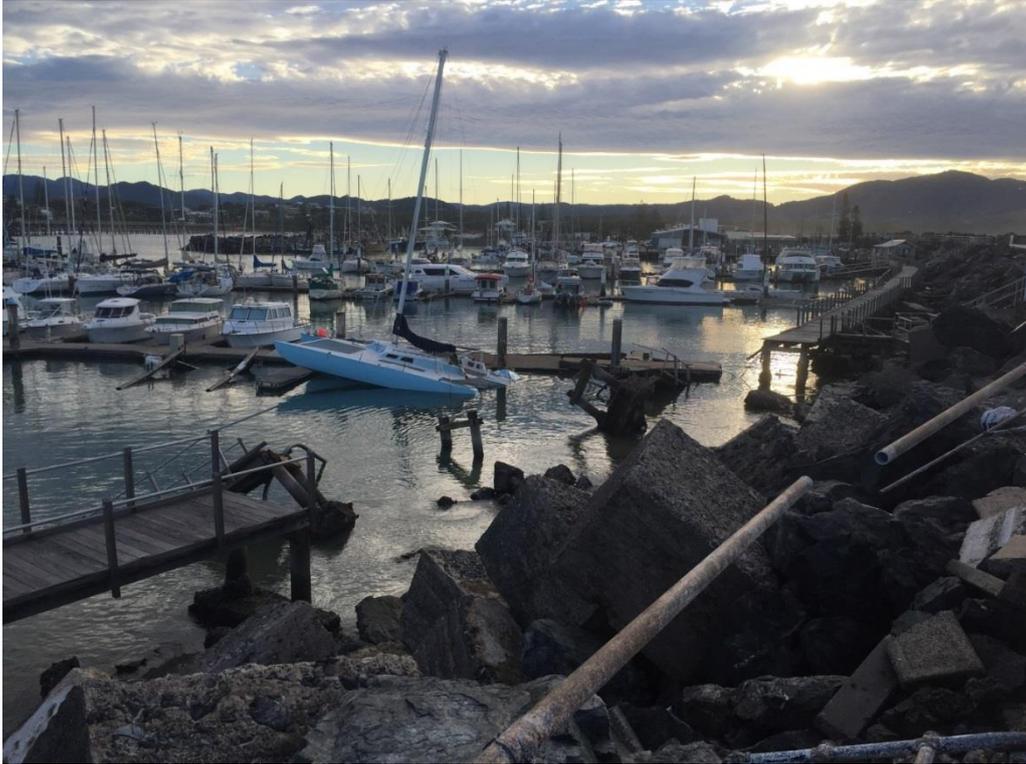
Figure 6b Damage to boardwalk and marina following storm. Damage to assets other than a breakwater costing greater than \$2m has never been recorded before in NSW

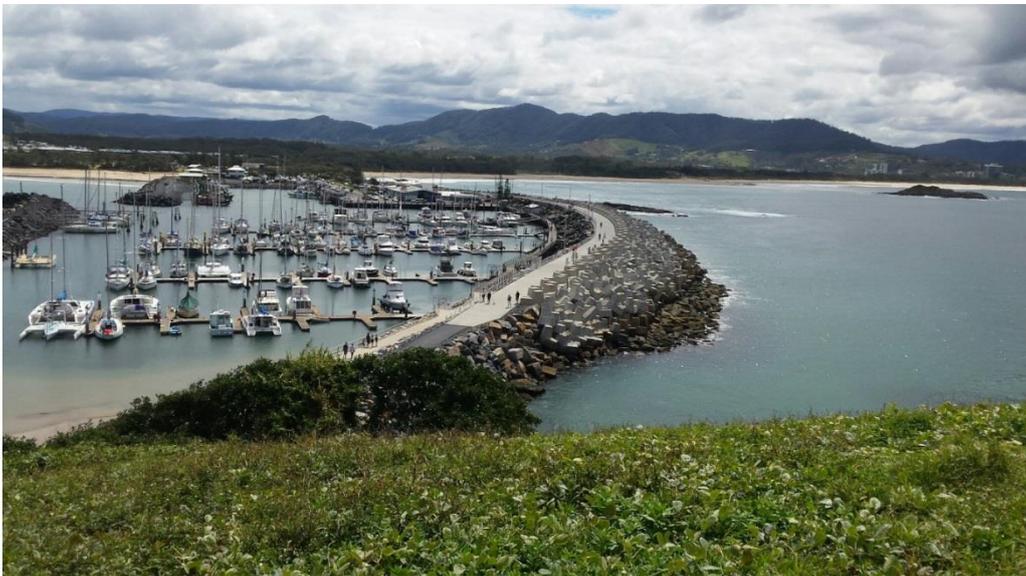
Figure 6c Completed breakwater showing 5m berm of 5–8t rock overlain by 12t Hanbars with 2 x 20t Hanbars as containment on seaward side

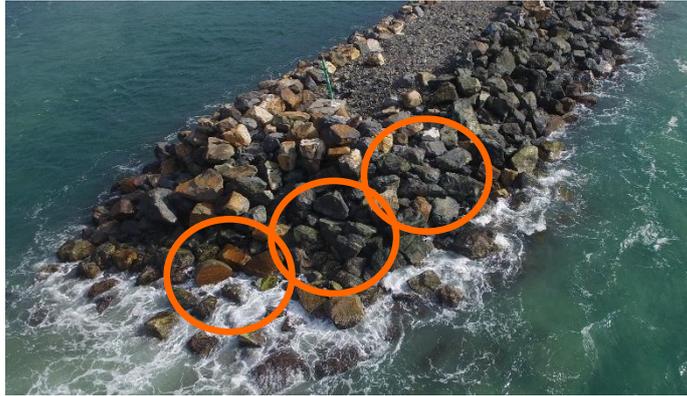
Figure 7 Port Macquarie north training wall head post-June 2016 storm (drone photo courtesy DoI – LaW)

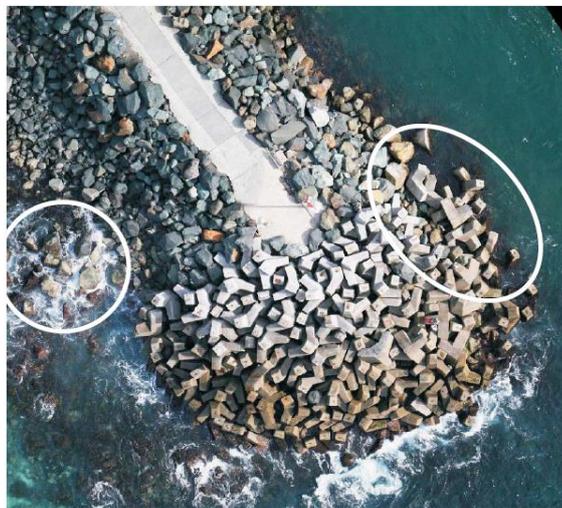
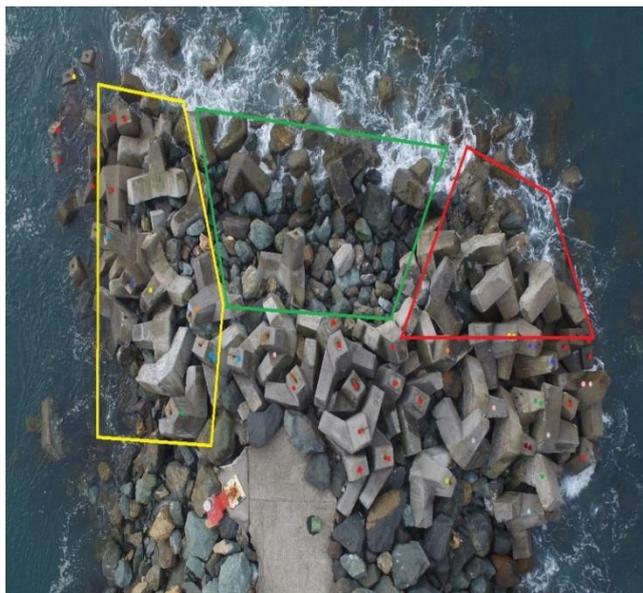
Figure 8a indicates damage due to a 40-year ARI storm on Forster head. Figure 8b indicates far more extensive damage due to the June 2016 storm assessed at 4–7 year ARI. Although the June storm was of smaller return period (Table 2) the damage was more extensive than was the case in the 2009 storm. The Forster head was scheduled to be repaired in the imminent future when the storm struck, which emphasises the importance of timing of repairs in reducing extensive damage to a structure due to a destructive storm event.

Figure 8a Forster head damage after 1-in-40-year ARI storm in 2009

Figure 8b Forster training wall – extensive head damage post-2016 storm

- Forster head, where repairs were just about to commence, sustained very heavy damage to the head when compared to previous storms. This was attributed to the current state of disrepair of the training wall head (Figures 8a and 8b).

- Initiate a system of life cycle analysis in tandem with physical and numerical modelling similar to the Monte Carlo type of analysis carried out at CERC in the USA to ensure timely repair of training walls such as the Forster training wall head.
- Utilise high K_d armour placement at training wall heads that extend into deeper water such as the Clarence north and south training walls to reduce the requirement of very high tonnage rock to reduce damage.
- Investigate the possibility of berms on the ocean side at locations where they may prove effective such as the current protection afforded to the Narooma north training wall.
- Utilise MHL's directional wave generator to test future repair design strategies using bimodal spectra.

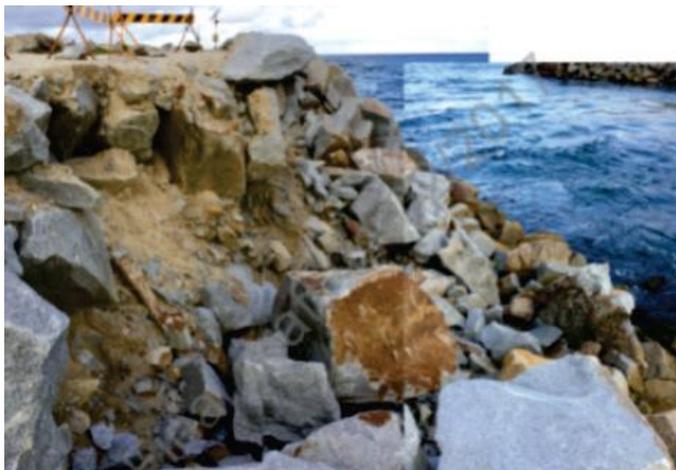
Figure 8c Post-2016 storm damage to Narooma north training wall

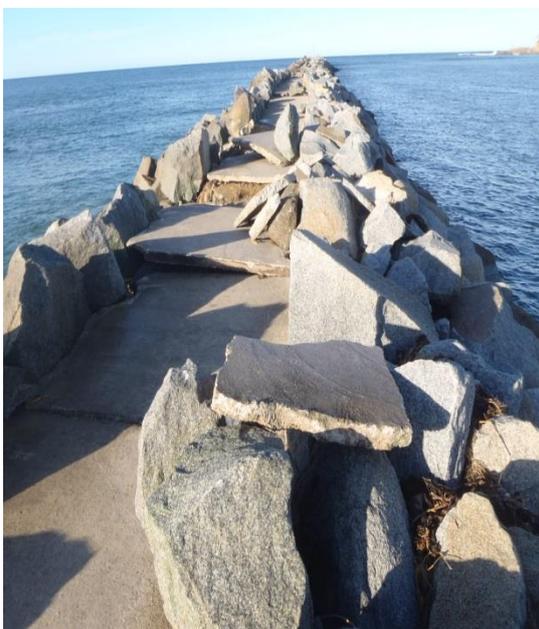
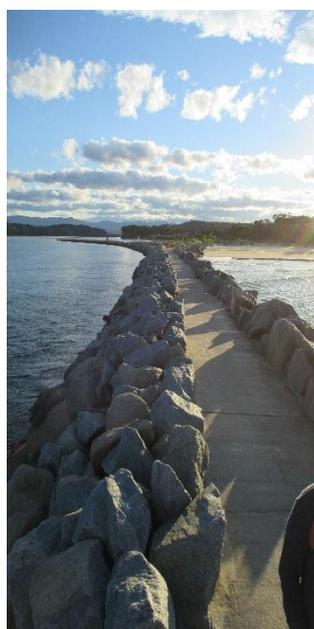
Figures 9a and 9b Moruya North crest post-June 2016 and 2014 after repair

- The Wollongong south breakwater is subject to extensive overtopping and the heritage wall was damaged. The heritage wall will most probably continue to be damaged unless protective armour or an engineered berm is placed in front of the wall.
- The Moruya north crest was badly damaged and this will continue unless a wall of armour is placed on the head and crest to reduce overtopping from the ocean side.
- Although the storm proved to be a trigger for the collapse of approximately 40 m of training wall at Narooma north the failure may be attributed to long-term scouring of the toe since 2011.

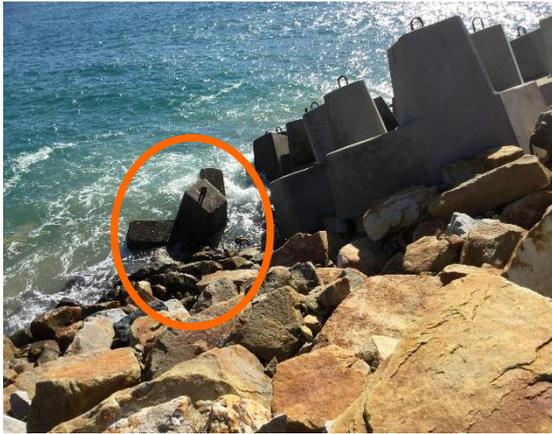
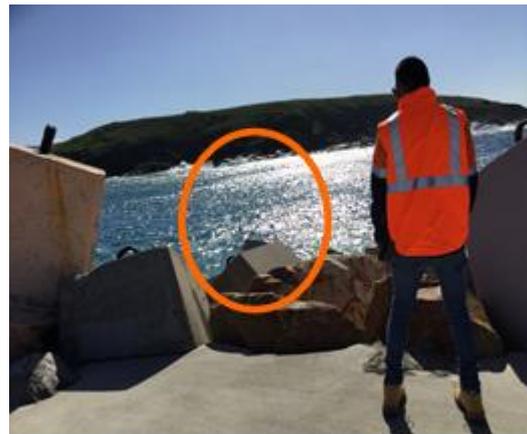
Figures 10c and 10d Relatively minor (<2%) damage to Coffs Harbour east breakwater head after June 2016 storm

- Modelled and repaired breakwaters such as Coffs Harbour east breakwater were subject to very little damage compared to the Crowdy Head breakwaters.

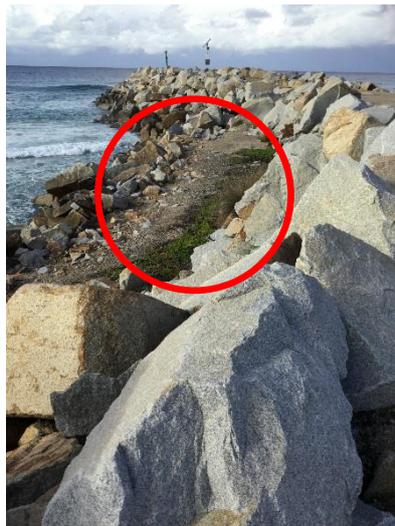
Figure 11 Relatively minor (<2%) damage to Narooma north training wall crest (in comparison with Moruya north) possibly due to unique berm construction on ocean side

- The berm on the Narooma north wall appeared to provide protection to this wall. Consideration could be given to designing berms to mitigate crest damage where increasing crest height would be less cost beneficial.

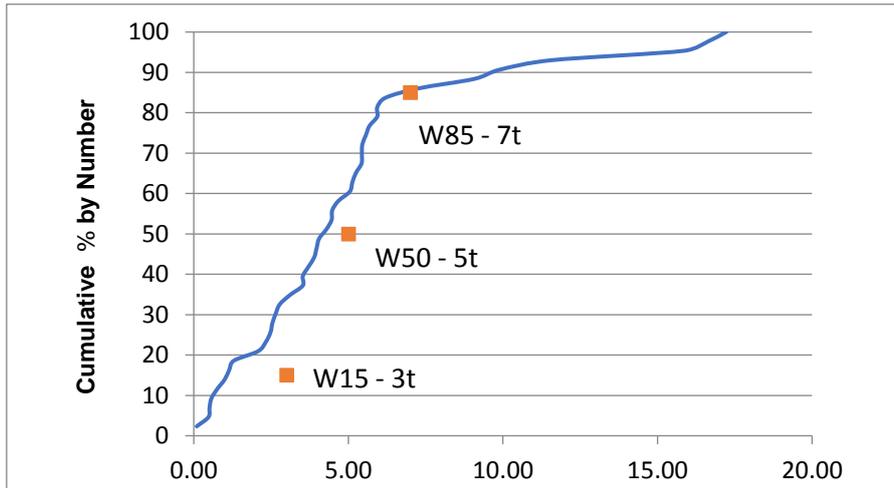
DoI – LaW has been very proactive in auditing repairs carried out under its contracts for repair. Figure 12a indicates non-conformances relating to rock armour specifications in the post-storm repairs to the Clarence training walls when audited (MHL 2017b) which were rectified after audit.

Figure 12a Armour distribution by number (CIRIA Rock Manual)

Parameter	By weight*	By number	Spec requirement
W85	15.95	6.75	7
W50=W	5.66	4.17	5
W15	3.56	1.07	3
W85/W15	4.48	6.31	2.33
