OBSERVING FISH BEHAVIOUR AT TIDAL FLOODGATES

Green B¹, Pease B²,

¹NSW DPI, Wollongbar Agricultural Institute, NSW

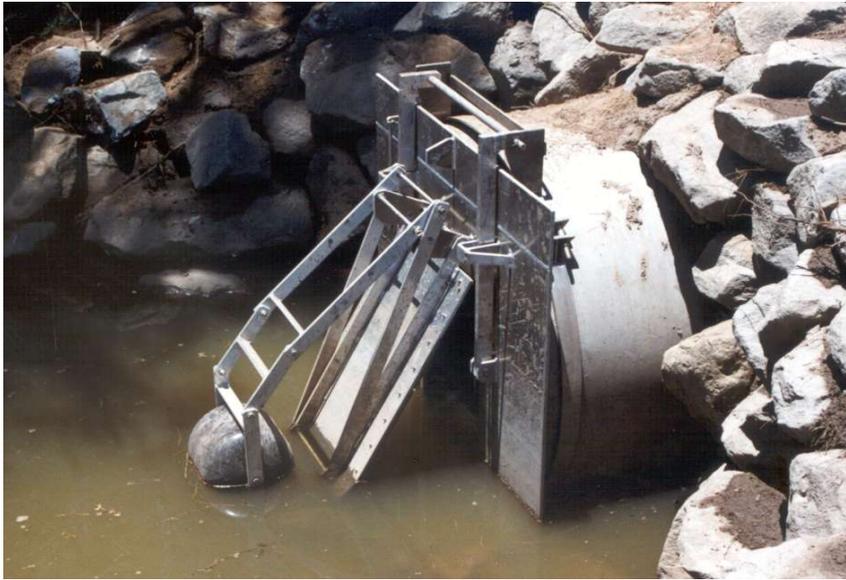
Figure 3 A typical tidally-activated gate fitted to a floodgate flap.

The existing structure at Little Broadwater consists of two winch-type floodgates fitted with two 0.9 x 0.7m automatic tidal gates, a concrete weir with removable drop boards and reverse floodgates (fish-flap). The automatic tidal gates are primarily designed to open by means of a simple float mechanism (Fig 3). As the downstream water levels rise due to tide or floodwaters, a float rises and closes the gate, however the closing of the panel can be controlled by adjusting the operational level and weight of the float. Equally, as the downstream levels fall, the float drops and re-opens the panel, permitting water exchange and fish passage.

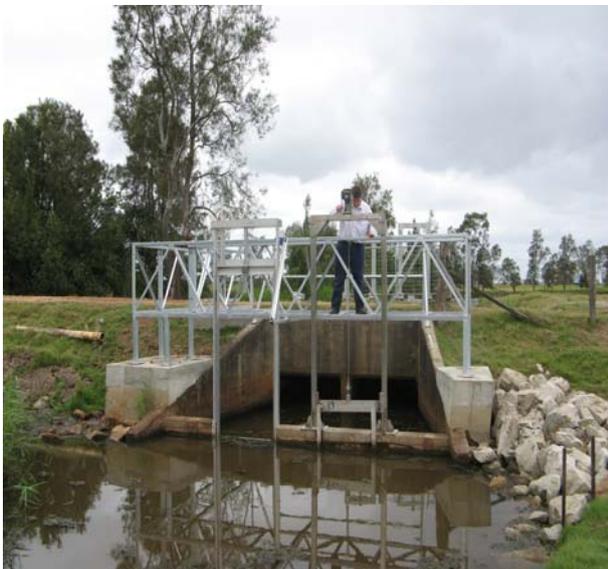
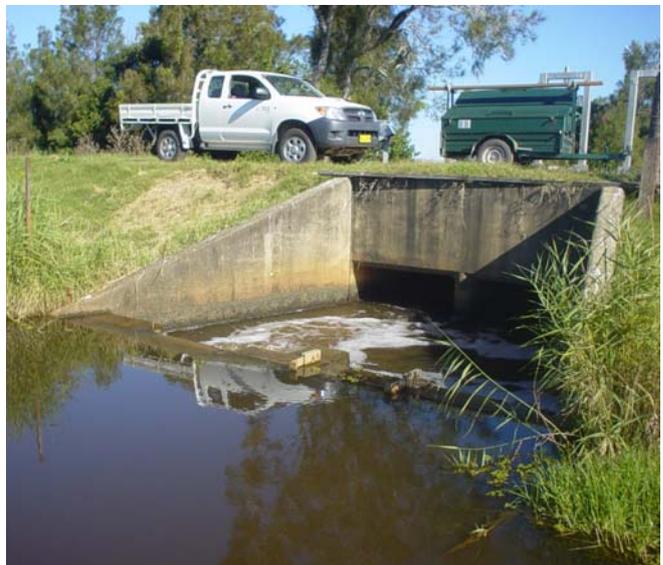
Figure 4 Changes to the water retention structure can be seen in these photos. The photo above shows the new gang-way and winch for the new under-shot over-shot weir that is replacing the old manual drop boards and the winch for the vertical lifting of the fish-flap.

Approximately 10m upstream of the tidal gates, a concrete weir or water retention structure has been installed. Its main purpose is to maintain a suitable water level in the wetland to minimise potential acid sulphate soils and provide habitat for aquatic fauna. The original structure consisted of removable drop boards and a reverse floodgate fish flap. Recent changes to this structure include a gang-way over the concrete weir, a new 'under-shot' mechanism and a winch on the fish flap (Fig 4). The gang-way allows safer access to operators to make changes to the under-shot mechanism and fish flap. This also allows smaller incremental changes to the sill level of the weir hence better control of the water levels in the wetland.

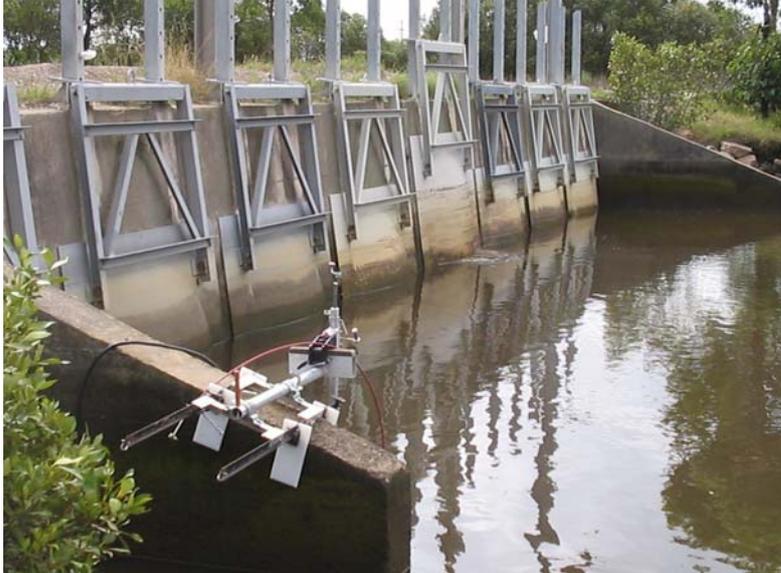
Figure 5 Eight floodgates located at Ironbark Creek draining Hexham Swamp.

The flood mitigation structure on Ironbark Creek consists of eight 2.13 x 2.13m box culverts each with a heavy, top-hinged floodgate. When water levels rise on the swamp side of the gates to a level higher than the Hunter River, the gates are forced open by this differential in hydrostatic pressure allowing water to flow out of Hexham Swamp. However, rising water levels on the river side, due to upper catchment floods or a rising tide, force the gates closed and prevent flow into Hexham swamp.

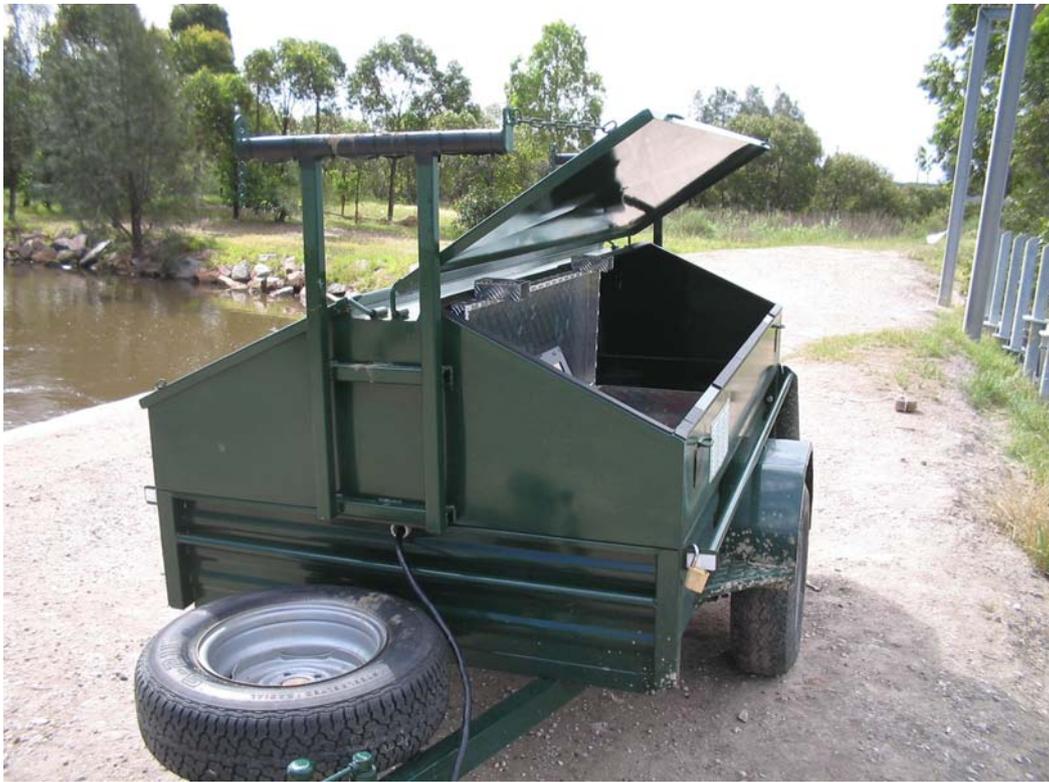
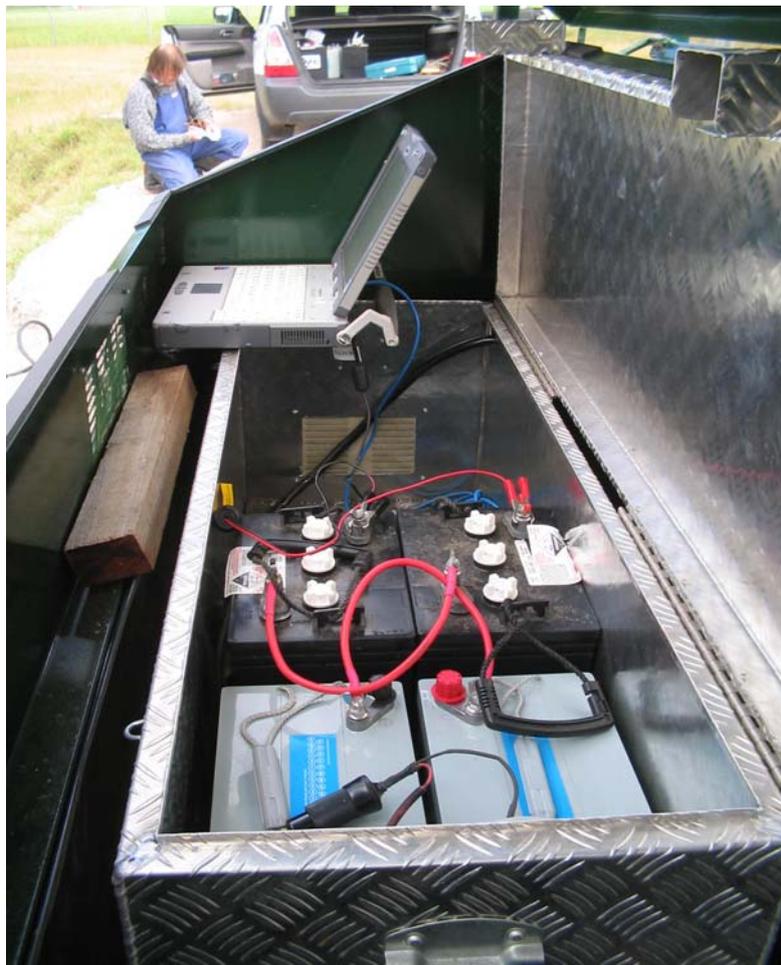
Figure 8 Mobile DIDSON trailer unit with lock-up capabilities. Trailer safely houses batteries and data storage unit and has recording capabilities of up to 48 + hrs, . dependant on data storage capacity.

An important aspect of this project was the construction and assembly of equipment needed for operating the DIDSON in a wide range of remote floodplain environments. We have set up a mobile sampling unit in a tradesman's trailer (Fig. 8) with flexibility to mount the DIDSON to a range of different structures at relatively short notice. The unit can be left in the field unattended but secure, due to the lock-up capability of the trailer unit. Recording periods of up to three full days are possible with the existing equipment, dependant on available hard disk storage capacity. The continuous recording period could be extended further with the use of solar panels mounted on the trailer doors. The mobile unit provides researchers with an excellent non-destructive sampling unit that is robust, can be deployed at short notice and can be deployed in a wide range of field conditions.

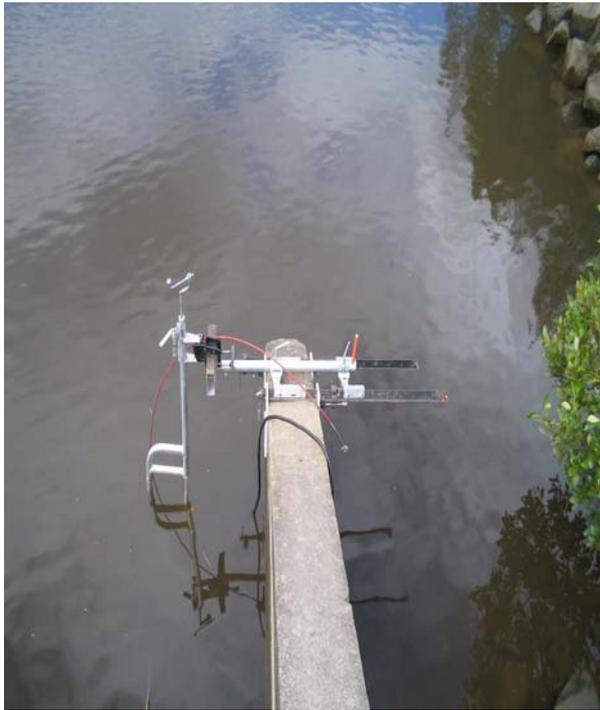
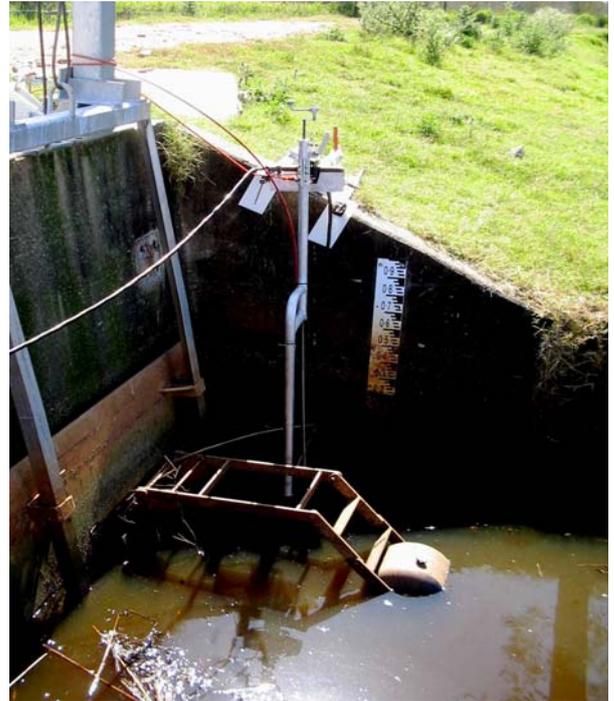
Figure 9 Typical DIDSON apron mount looking downstream from top of floodgate, Ironbark Creek, Hunter River, Newcastle and the downstream section at Little Broadwater floodgates, Clarence River.

The floodgate apron mount uses two builders clamps. This enables the operator to mount the DIDSON onto a floodgate apron wall.

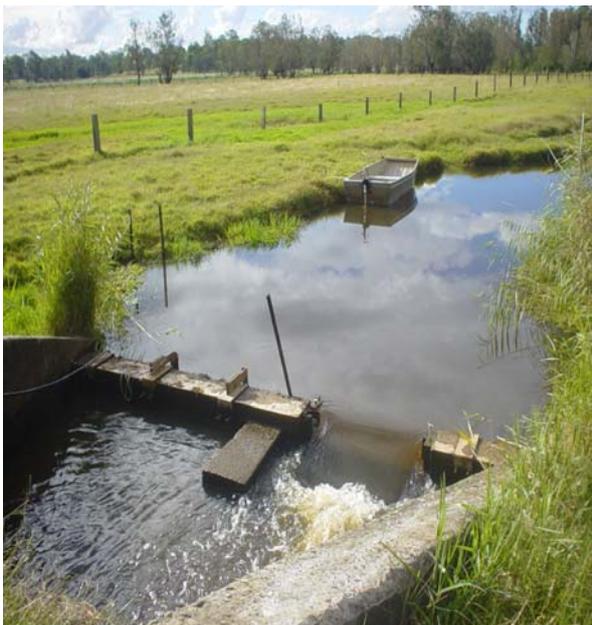
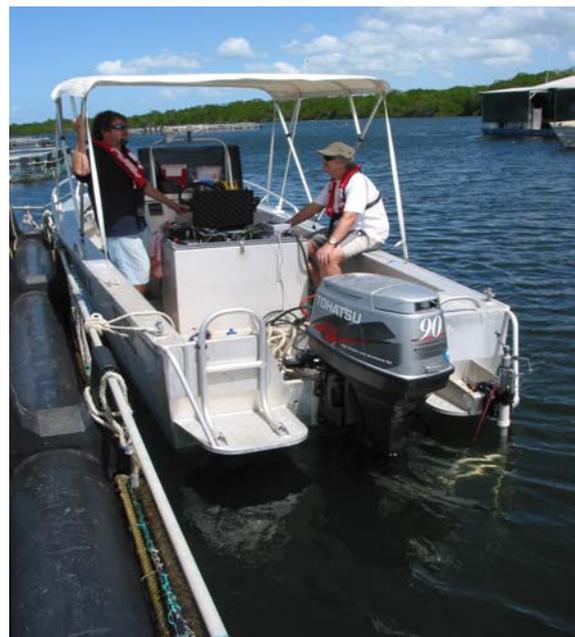
Figure 10 Looking upstream at the tinnie from the culvert side with the water retention structure in the foreground and a larger boat mount on the stern transom. See DIDSON bracket bottom right hand corner on the larger boat.

To mount the DIDSON on a boat or mobile platform, a bracket that usually attaches the outboard motor to the transom was modified and attached to the DIDSON bracket to allow mounting on the transom.

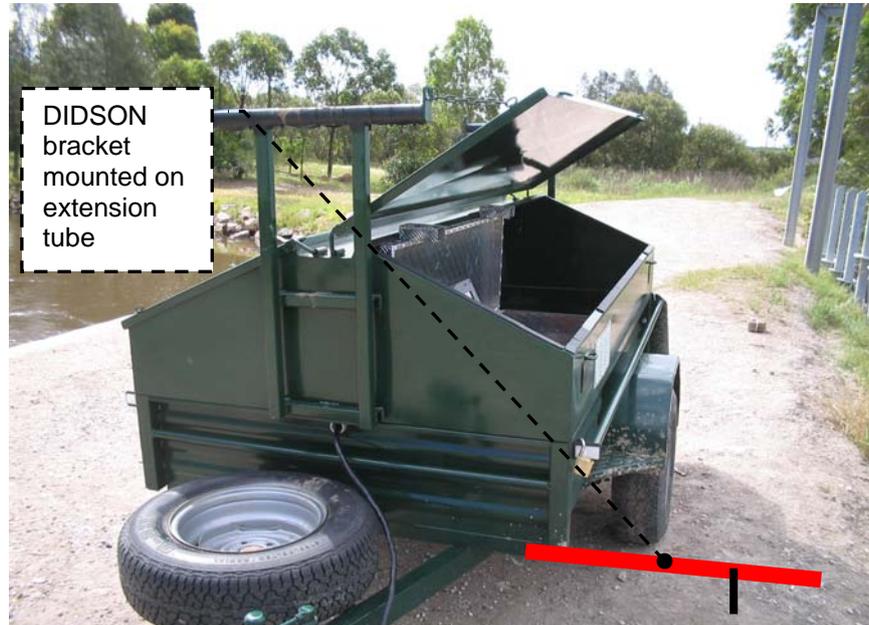
Figure 11 Mobile DIDSON trailer with lock up capabilities showing location of trailer mounting system.

A bracket was designed to mount directly to the trailer. A square metal tube was inserted into the trailers frame and extended over a culvert wall or similar. The Floodgate Apron wall mount was then attached to the metal tube. The secured camera literally hung over the edge of the structure into the water.

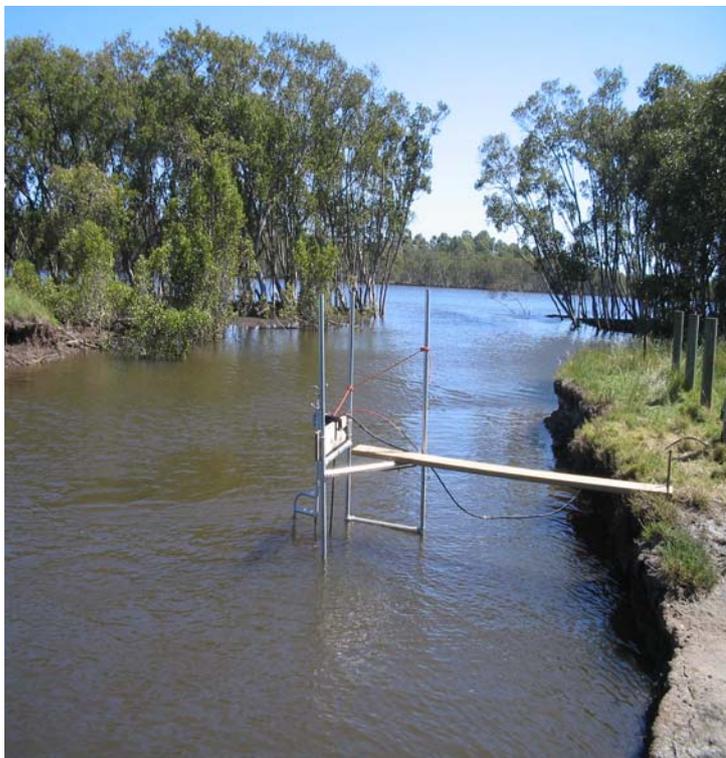
Figure 12 Pole or pipe frame mount on Cobans Creek, Hunter River, Newcastle, NSW

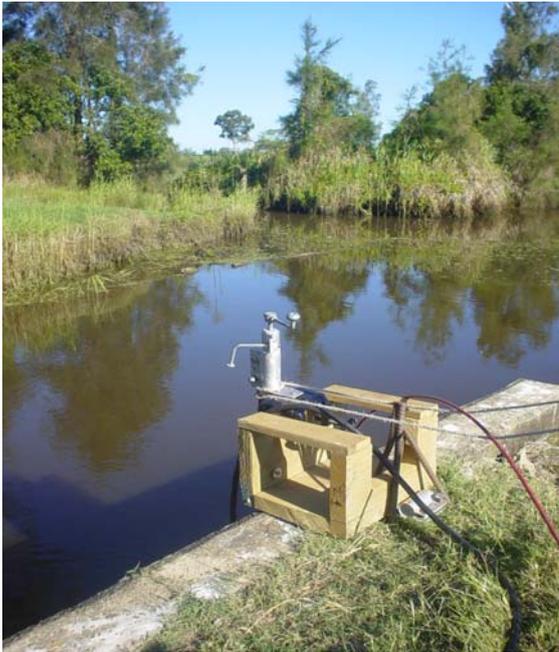
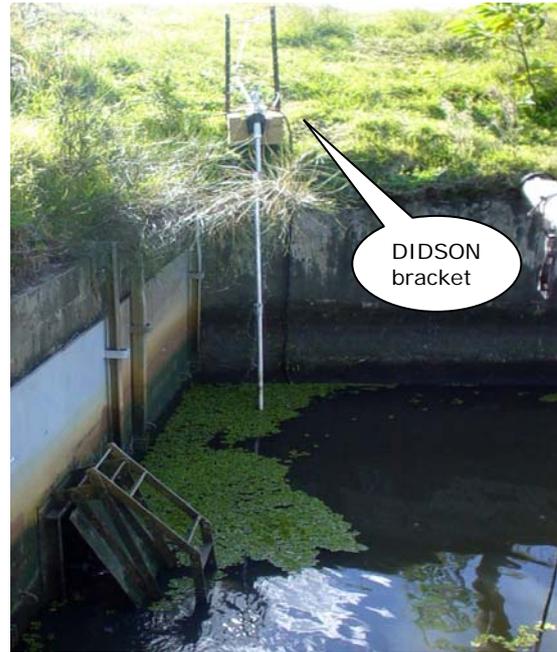
Figure 13 Wooden frame mount on edge of floodgate apron, Little Broadwater and a wooden frame mount on edge of apron wall with full DIDSON extension bracket, Denny's Gully, Coldstream River.

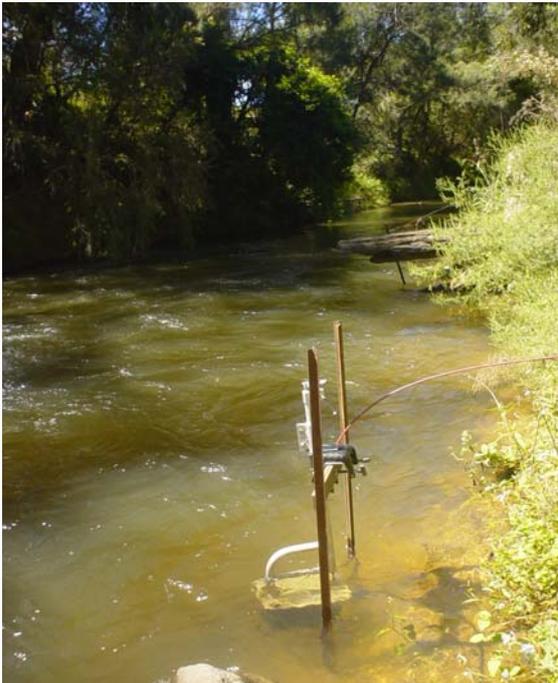
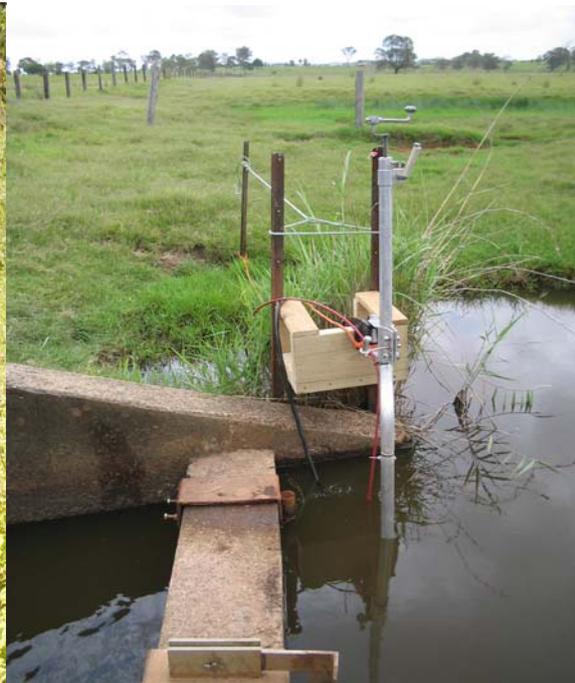
Figure 14 Star-picket mount in Blaxlands Creek, Orara River, NSW and star-picket combined with wooden frame mount at Little Broadwater, Clarence River, NSW.

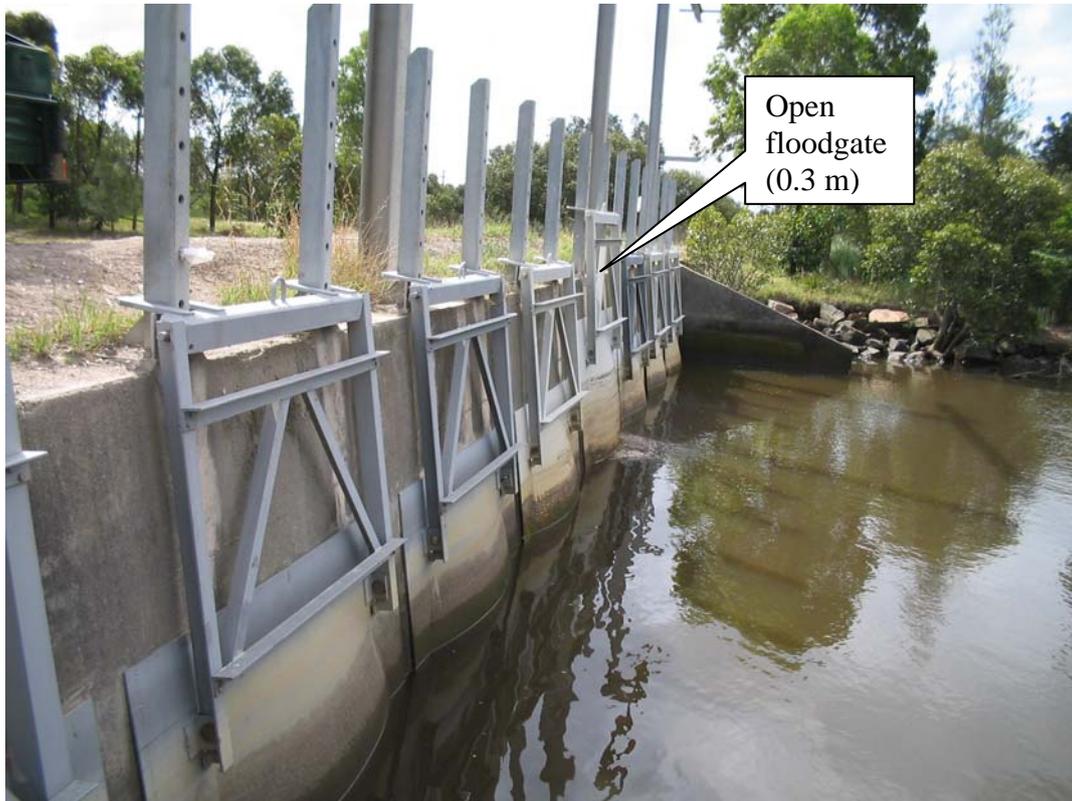
Figure 20 Floodgates at Ironbark Creek, Hunter River. Notice open floodgate at the current 0.3m level.

Our preliminary observations indicate that fish are moving freely through the restricted opening (0.3 m) in the single floodgate in the barrage at Ironbark Creek (Fig 20). However, further analysis of video footage is needed to confirm the free movement of fish and other animals through these structures during all stages of the tidal and diurnal cycles. Turbulence at this site is often so extensive during high flows as the tide rises and falls, that the images are obscured by “snowy” interference.
