Deliberations on Private Property Coastal Hazard Line Assessments in NSW and Recent Experience including the Effects of Climate Change (Barlings Beach, Eurobodalla and Boomerang Beach, Great Lakes)

G Blumberg

gbaCOASTAL Pty Ltd, Sydney, NSW

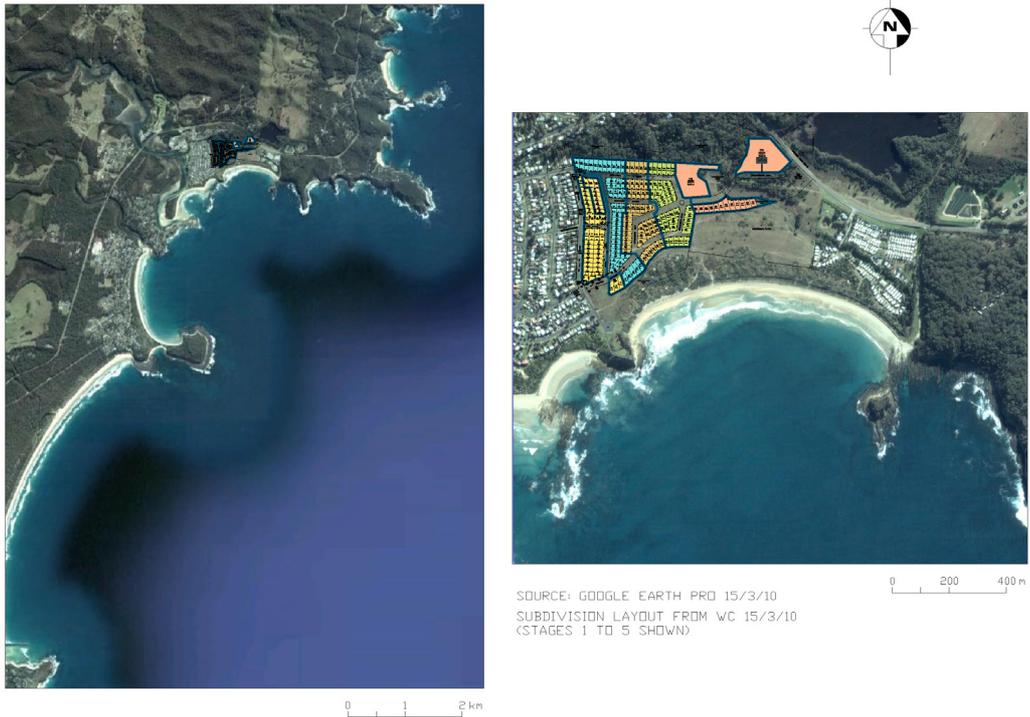
Figure 1 – Barlings Beach Study Area

A residential subdivision is being developed at Barlings Beach, Batemans Bay on the NSW South Coast. Approximately 1 km in length, the beach faces S/SSE and enjoys protection by prominent headlands and an offshore reef (**Figure 1**). Initial coastal engineering assessments to describe the coastal hazard for the subdivision were undertaken in 2005 and 2009. In 2009, Eurobodalla Shire Council requested further information from the developer, particularly in relation to the effects of climate change. GBAC was retained to address the additional requirements and develop refined maps for the 2050 and 2100 CHLs.

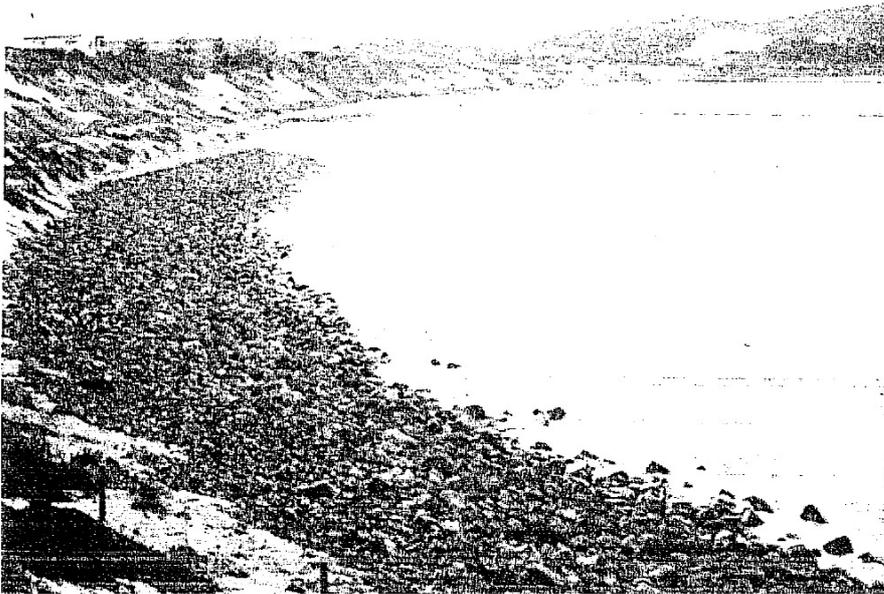
Figure 7 – Storm erosion at Boomerang Beach (June 1978)

Coastal process investigations reported in PWD (1985) included a photograph taken in June 1978 showing what appeared to be a lag deposit of cobble sized material towards the southern end of the beach. It was of interest to check whether this deposit may present as a scour resistant horizon beneath the site or its fronting dune and back beach (**Figure 7**).
