REINSTATING ESTUARINE FORESHORE HABITAT THROUGH THE INSTALLATION OF ENVIRONMENTALLY ENHANCING PROTECTION STRUCTURES

T. Pinzone¹, E. Thornton¹, A.F. Nielsen¹, K. Duchatel¹, Dr P. Hackney²

¹AECOM, Sydney, NSW

²Parramatta City Council, NSW

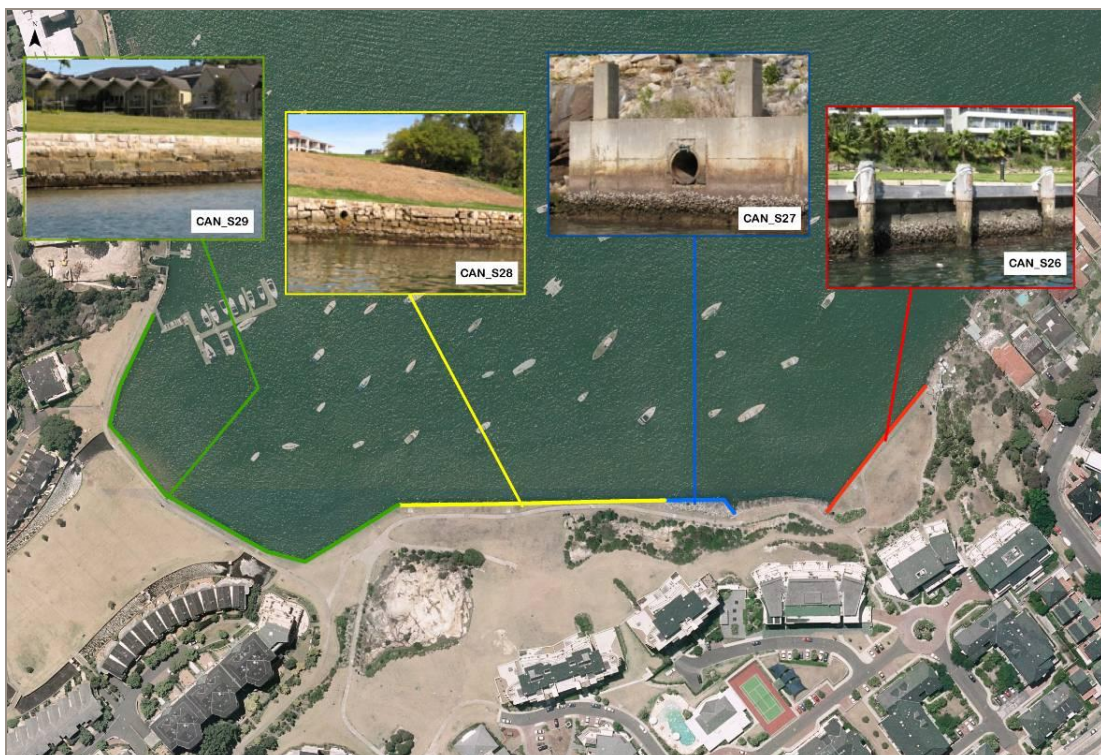
Figure 2 Seawall naming convention

A discrete seawall was defined as a structure distinct, either by type or condition, from those adjacent, irrespective of length. A naming convention was derived based on the LGA in which the seawall was located and a sequential numbering system assigned from east to west along the LGA foreshore (Figure 2).

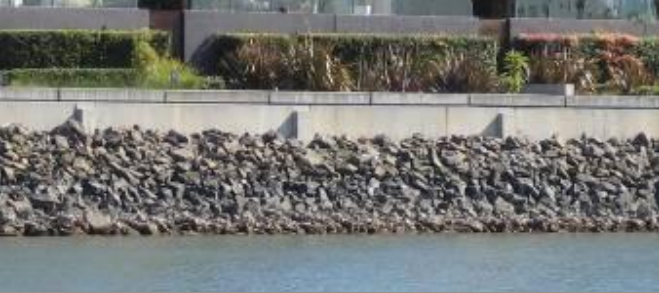
Seawall Condition Description	Example
<p>Excellent:</p> <ul style="list-style-type: none"> • No defects observed • Structure is functioning as intended

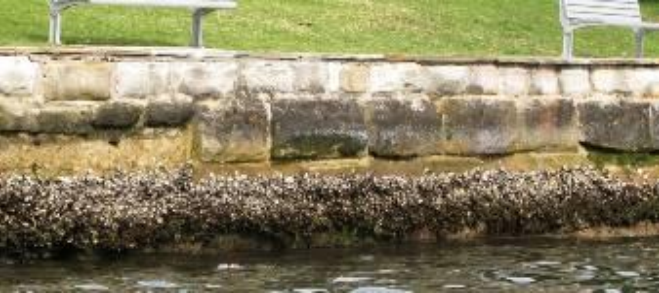
<p>Good:</p> <ul style="list-style-type: none"> • Minor defects observed such as weathering and loss of grout • Structure is functioning as intended

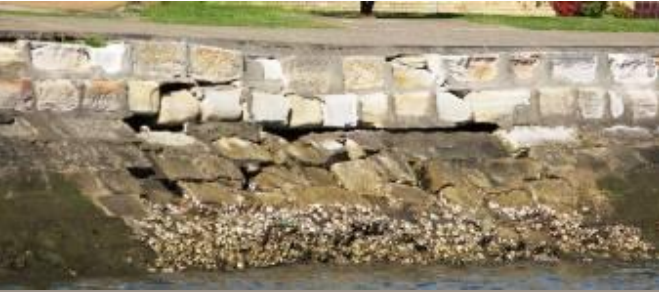
<p>Poor</p> <ul style="list-style-type: none"> • Major defects observed • Structure is at risk of failure without remedial action • Reduced functionality

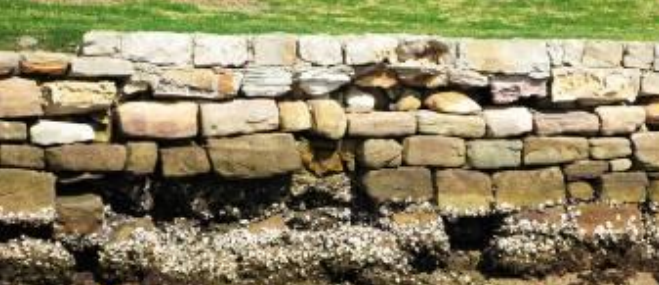
<p>Failed</p> <ul style="list-style-type: none"> • Major defects observed • Structure or parts of structure have collapsed • Structure is no longer functioning as intended

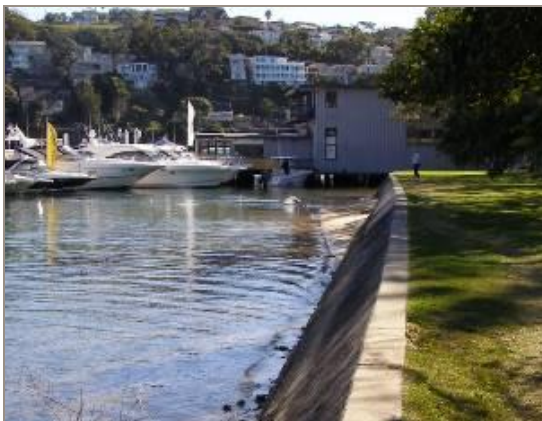
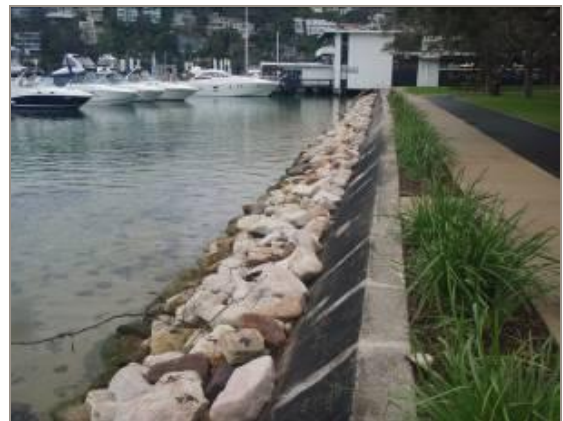
Figure 3. (left) Seawall prior enhancement (right) Rock rubble - artificial reef habitat

- Creation of an artificial reef habitat using boulders, woody debris, or rock clumps (Figure 3)
- Increased roughness and texture of seawall surfaces through the attachment of objects
- Provision of cavities or not grouting between blocks to create sub-tidal cave habitat or smaller habitat pockets and crevices
- Intertidal vegetation planting area provided by outer and inner sill and appropriate planting media between sills (Figure 4)
- Creation of rock pools that retain water at low tide and Figure 5)

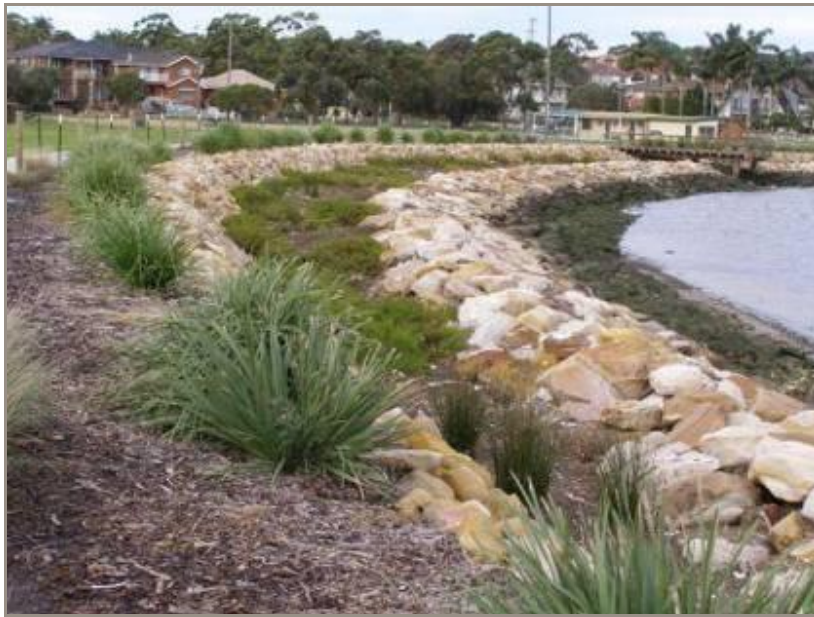
Figure 4. Intertidal saltmarsh area between rock sills

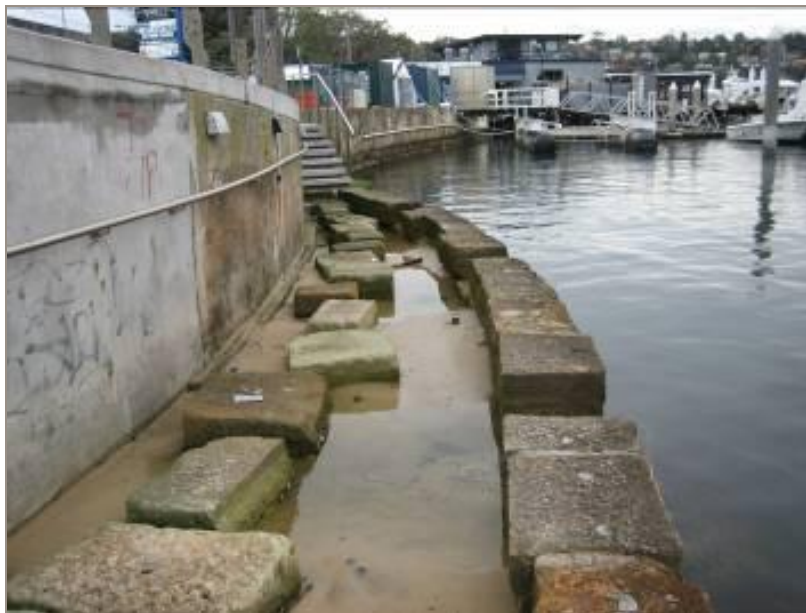
Figure 5. Rock pool created to retain water at low tide
