# 10 YEARS ON: OVERCOMING OBSTACLES TO IMPROVING FISH MIGRATION AT COASTAL WEIR AND ROAD CROSSING BARRIERS

<sup>1</sup>NSW Department of Primary Industries – Fisheries

## Abstract

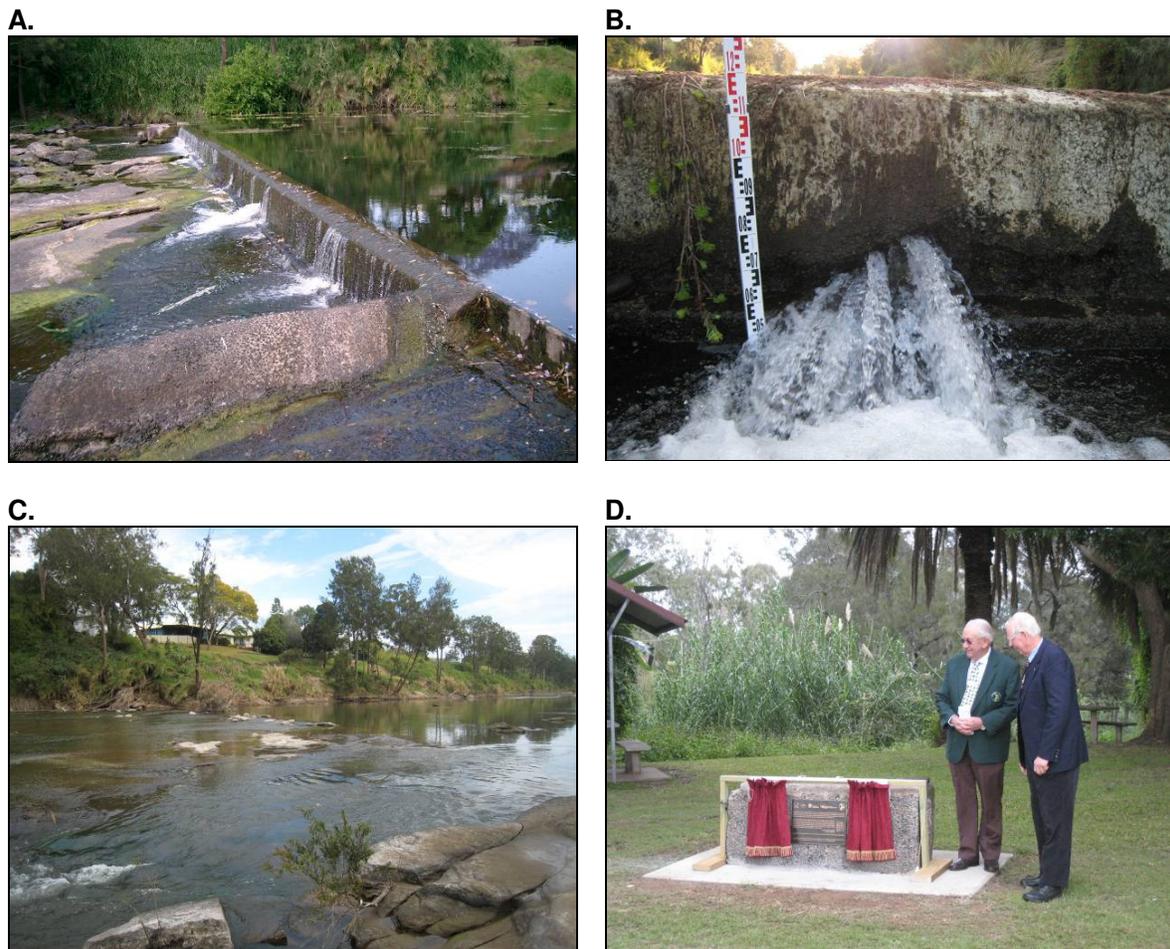
**Figure 1:** A. Manyweathers Weir restricted fish passage to over 1000 km of waterway in the Richmond catchment. B. State Water Corporation considered the weir redundant, with multiple breaches limiting the weir’s capability to pool water during drought conditions. C. The weir was removed in its entirety in 2009, with a section of the weir maintained to honour Richmond Manyweather (D).

Manyweathers Weir was constructed on behalf of the Water Resource Commission, with ownership of the weir passing to State Water Corporation in 2007. Minor structural modifications were made to the weir in 1970 to improve the structure's water retention capabilities; however, as the weir was never used for its original purpose, no further modifications or maintenance occurred. Structural stability assessments of the weir in 1998 indicated that the weir was structurally sound; but multiple breaches limited the weir's capacity to pool water during drought conditions (Fig. 1B).

Manyweather family, while also meeting with the local heritage society. Both the family and the heritage society agreed with the justifications provided by DPI Fisheries and State Water Corporation as to why the weir should be removed, with the proviso that the heritage value of the weir was preserved. One such action was to retain a portion of the weir that was placed at the top of the river bank, upon which a plaque was mounted that commemorated the weir and Richmond Manyweather (Fig. 1D).

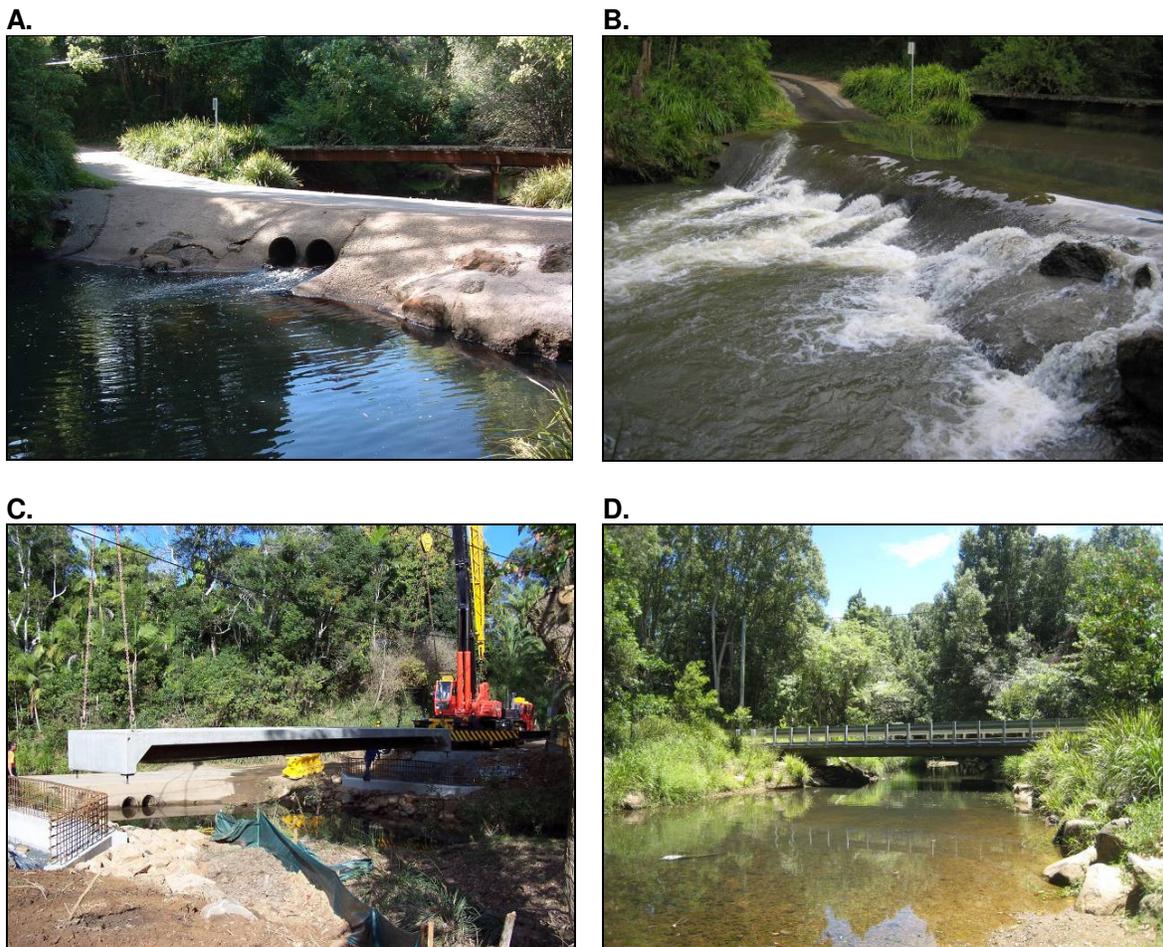
**Figure 2:** Coral Avenue causeway restricted fish passage during base flows due to high velocities through the two pipe culverts (A), and during elevated flows due to excessive head differential (B). C) Prefabricated Doolan Deck bridges were craned into place, thereby reducing onsite construction costs by up to 50 %. D) Coral Avenue bridge provides improved fish access to over 25 km of upstream habitat.

The Coral Avenue road crossing (19 m x 8 m) was a two-celled pipe culvert that traversed the Brunswick River near the township of Mullumbimby. The pipe culvert causeway was located at the upper extent of the Brunswick estuary, with the causeway acting as a minor tidal barrage. Additionally, the two pipe culverts constrained the downstream water flow, resulting in excessive water velocities that limited fish passage to over 25 km of upstream habitat (Fig. 2A).

Public Safety & Design: In 2004, DPI Fisheries reinitiated conversations with Byron Shire Council to replace Coral Avenue causeway with a fish friendly design. In addition to fish passage, public safety concerns were raised due to the regular overtopping of the causeway during flood events. The causeway provided the only access over the Brunswick River to 19 landholders, with vehicle and public access considered dangerous during elevated flows (Fig. 2B).

To address landholder access concerns, a channel spanning bridge was proposed. Bridges are the preferred design option by DPI Fisheries for waterway crossings; however, bridges display the highest capital costs to construct. In order to keep construction costs low, a prefabricated Doolan Deck was proposed for the site. Prefabricated bridges can reduce construction costs by up to 50 % as onground civil works are limited to abutment formation thereby often negating the need for site dewatering (e.g. coffer dams). Once the abutments are formed, a crane lifts the prefabricated bridge deck into place in the space of one day (Fig. 2C).

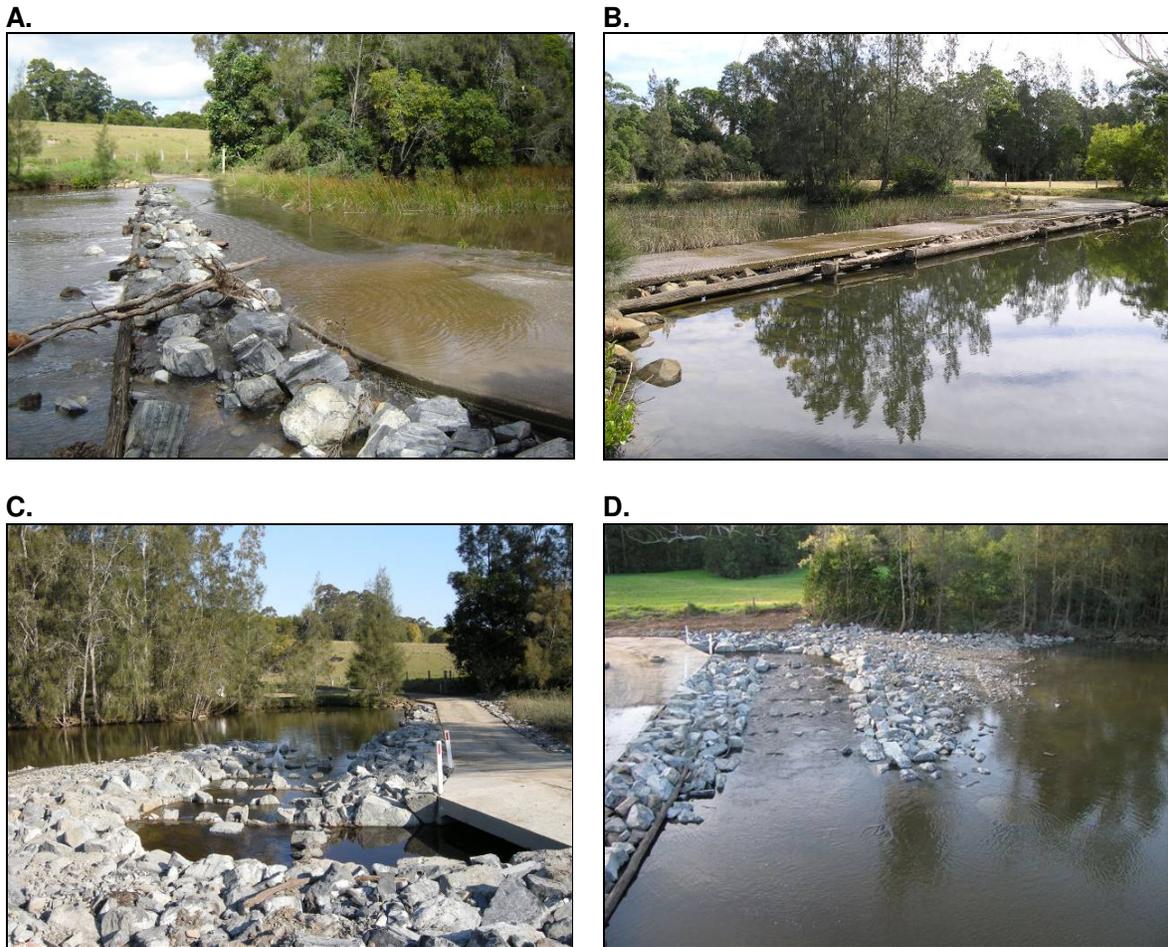
**Figure 3:** A & B. Locketts Crossing restricted fish passage to over 60 km of upstream habitat due to excessive headloss. C & D. A partial-width rock-ramp fishway was installed on the downstream side of the crossing that led to a single box culvert.

Locketts Crossing is a single-lane causeway measuring 35 m long by 4 m wide that spans the width of the Coolongolook River in the Wallis Lake estuary (Fig. 3A & B). The original causeway was a concrete capped crossing that acted as a tidal barrage, with the natural tidal limit occurring 1.5 km further upstream. In addition, fish passage was blocked during base flows due to a head differential of 750 mm on the downstream side. The crossing provides the primary access for several landholders located on the eastern side, and thus could not be considered for removal. Locketts Crossing was ranked as the highest priority road crossing barrier in the Hunter Central Rivers CMA due to its location as a tidal barrier, and the fact that fish passage was restricted to over 60 km of high integrity upstream habitat.

Following further assessment, a partial-width rock-ramp fishway design was proposed on the downstream side of the causeway that led to a single 3 m wide box culvert (Fig. 3C & D). The rock-ramp fishway and box culvert were designed to provide fish passage during base flows, with landholder access being maintained. Additionally, the invert levels of the fishway and box culvert were set so that tidal flows would not pass upstream, thereby maintaining the upstream freshwater pool. During higher flows, the rock ramp would provide added roughness around the bank which facilitates fish passage until structural drownout occurs. The provision of rock protection on the downstream side of the causeway also further stabilised the causeway, negating any structural stability concerns associated with the smaller box culvert.

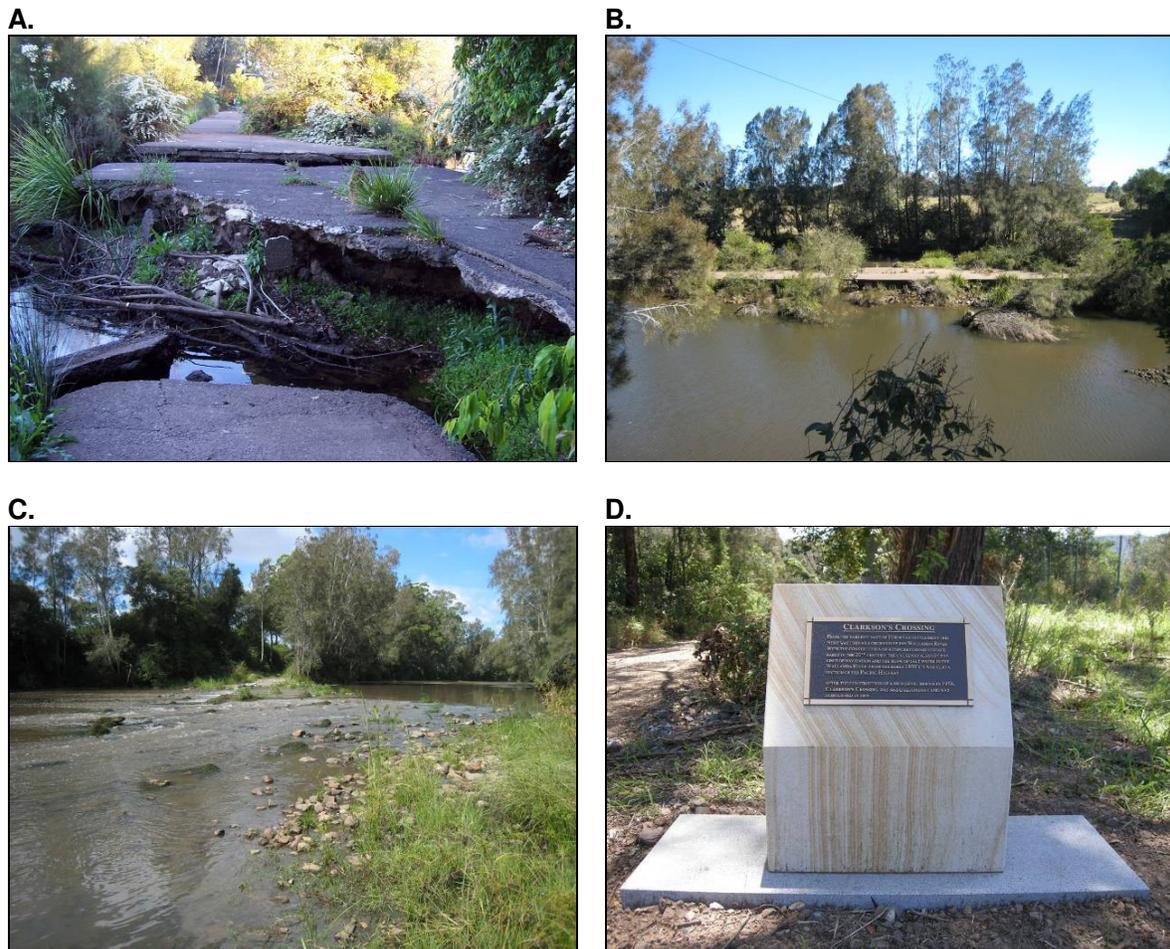
**Figure 4:** Clarksons Crossing (A, B) was a decommissioned, dilapidated causeway that restricted fish access to over 50 km of upstream waterway. C) Removal of the causeway and regrading of the existing rock rubble improved fish passage while securing the upstream freshwater pool from saline ingress. A memorial was erected along the south bank to commemorate the history of the crossing.

Heritage: Clarksons Crossing was originally constructed in the early 1900's, initially as a bed level crossing, and subsequently upgraded over time to the elevated causeway that was decommissioned in 1958. Questions were raised over the heritage significance of the crossing prior to removal. DPI Fisheries found no record of heritage significance in the local or State Heritage Registry. Despite this, DPI Fisheries approached the local heritage society and proposed that a memorial be erected at the top of the southern approach to commemorate the history of the crossing (Fig. 4D).
