Entrance realignment and berm profiling of a small coastal lagoon to control dune erosion

D Wiecek¹ and P Gangaiya²

ABSTRACT

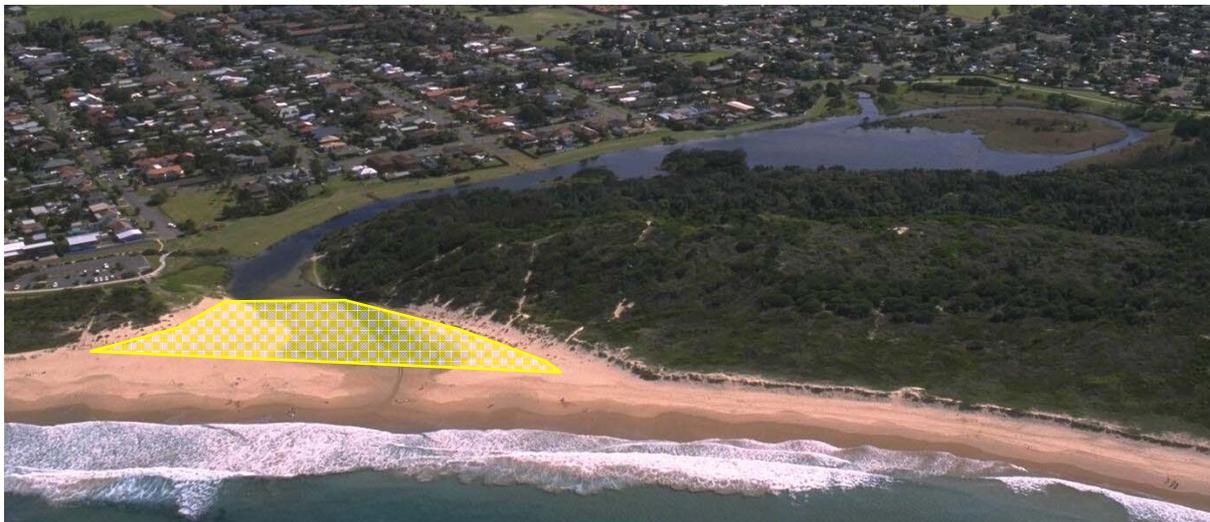
Figure 2: Oblique aerial photo of Bellambi Lagoon showing the area of unvegetated low lying sand area maintained by the migrating entrance channel (shaded) (taken 21/4/2000, OEH).

Entrance channels of intermittently closed or open lakes and lagoons (ICOLLs) have a natural tendency to migrate up and down the beach in response to discharge of floodwaters and coastal processes. As a result, the location where breakout occurs across the beach berm can differ markedly over time, in the order of hundreds of metres in some instances. This migrating behaviour of the entrance channel maintains an unvegetated sand area landward of the beachface, which is typically low lying and wide in comparison to the rest of the subaerial beach (Figure 2).

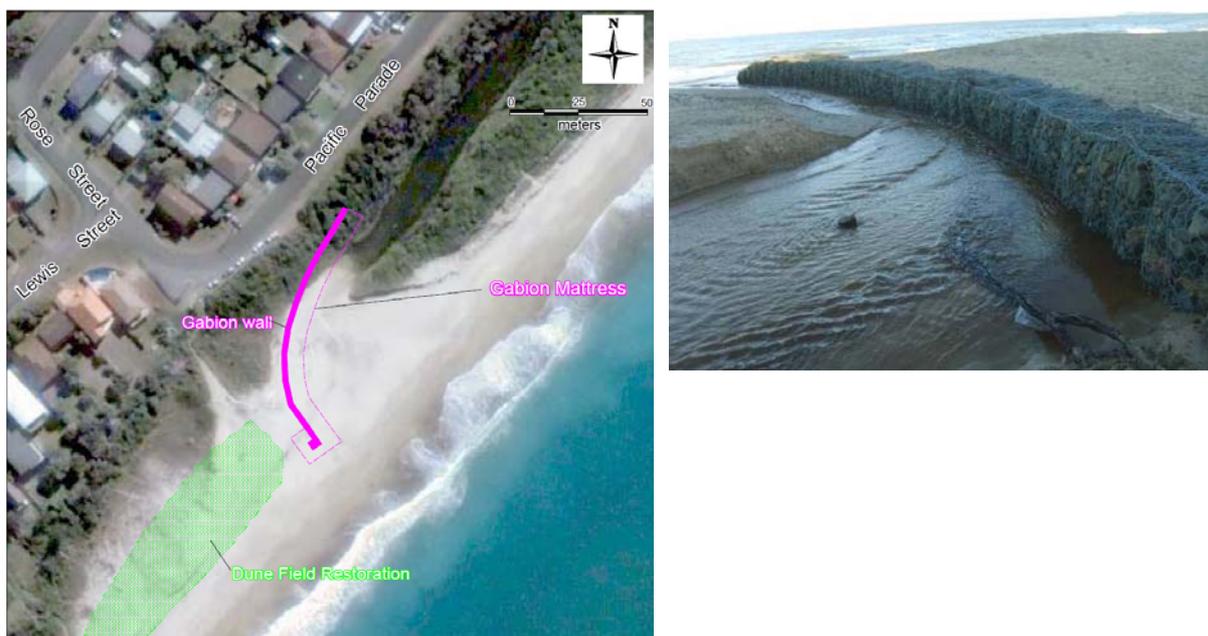
Figure 3: Design of the training wall that was constructed at Racecourse Creek to control entrance migration south (left) (from Worley Parsons, 2010a). Note how the training wall

does not extend beyond the beach berm like a conventional training wall would. Photo of the training wall (right) taken June 2008 (from Worley Parsons, 2010b).

Where migrating entrance channels have led to impacts on adjacent infrastructure, management intervention has often been necessary. The management response has been to either use hard engineering structures such as seawalls or training walls, or softer techniques involving ongoing beach scraping and channel realignment. Training walls were used with success at the entrances of both Dee Why Lagoon (1980's) and Racecourse Creek at Old Bar (1990's) to limit the northern and southern extents respectively of entrance channel migration. In both cases the migration of the channel created a threat to assets from both flood discharge scour and erosion from storm waves. At Dee Why Lagoon, the northern channel migration had lowered the sand area in front of the surf club, which enabled the 1974 storm waves to directly attack the surf club foundations (PWD, 1984). At Racecourse Creek, both flood discharge scour and storm wave action were a threat to private properties (AWACS, 1991). The training walls used at both these locations are not considered conventional training walls, in that they were designed to be partially buried and project no further seaward than the current berm (Figures 3 and 4).

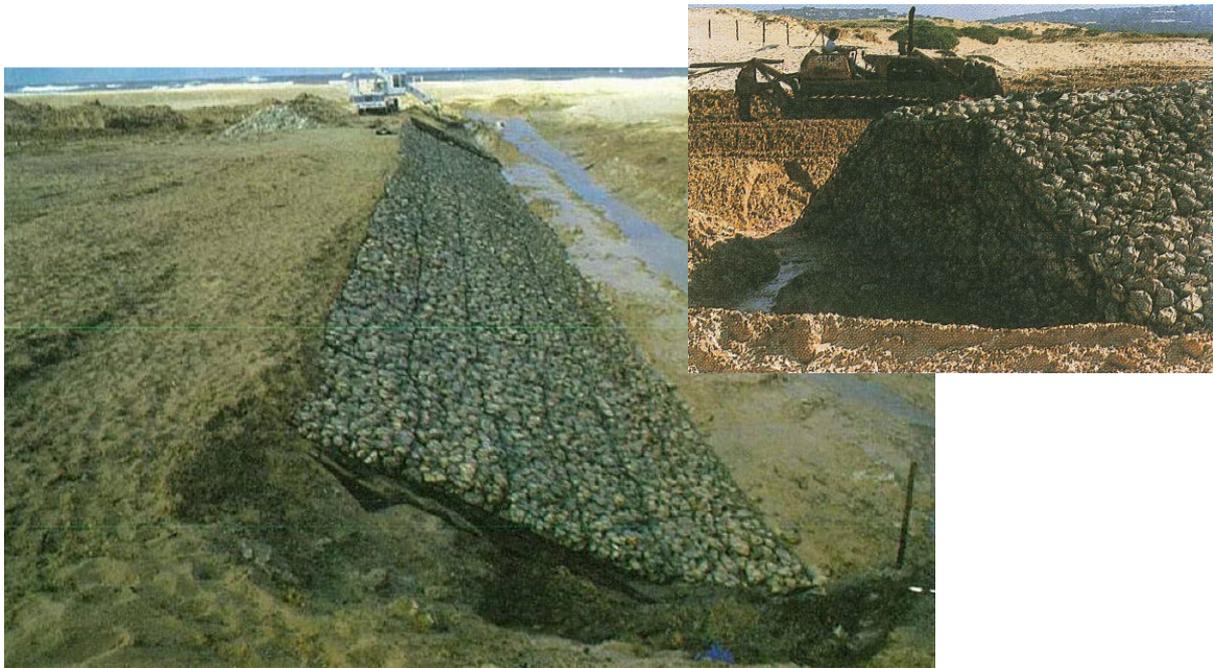
Figure 4: The partial training wall under construction at Dee Why Lagoon entrance (from PWD, 1984). The main photo shows the intent for the training wall to be largely buried.

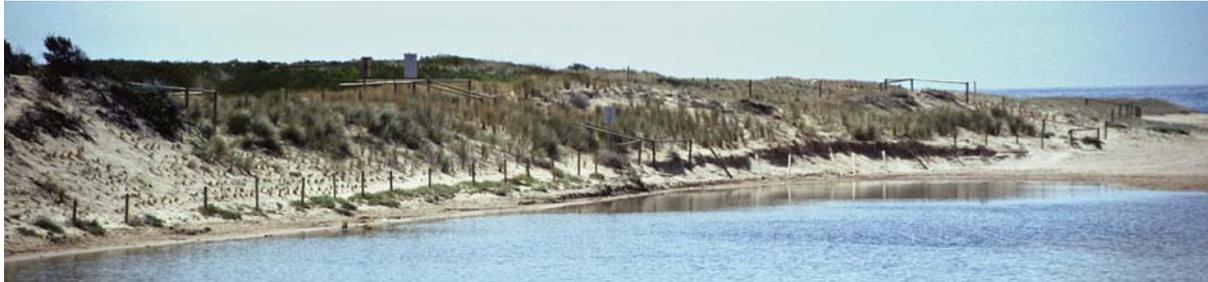
Figure 5: Photo of the completed dune stabilisation works as they looked two years after completion in October 1992. Dune erosion has already occurred and part of the fencing has been undermined.

species, fencing the dune, and creating a formalised access path down the dune face to the entrance channel. These measures stabilised the dune erosion scarp initially, but as little as two years later undercutting of the dune had occurred to the point where a new erosion scarp was created and access control fencing was undermined (Figure 5). Since this time, erosion of the dune face has continued. This suggests that the processes causing the erosion were not addressed by the dune stabilisation works and that other management actions would need to be considered in conjunction with these works to significantly reduce dune erosion along the entrance channel.

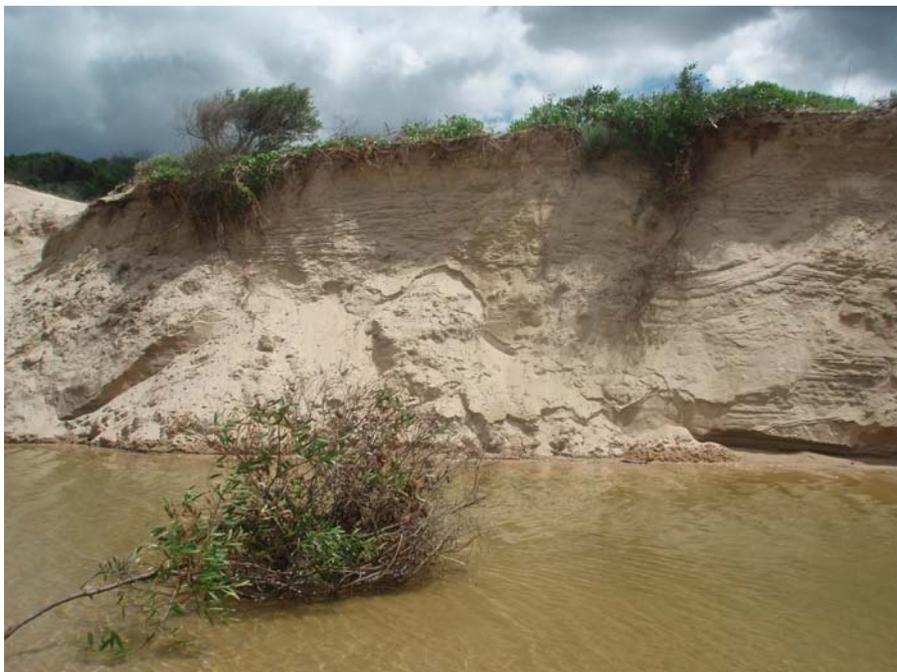
Figure 6: Dune erosion scarp after several natural entrance openings at the base of the dunes causing scour and undercutting of the dunes (photo taken 29/2/2008).

Significant exacerbation of the dune erosion occurred after several natural entrance openings along the base of the dunes over the period 2007 to 2008 (Figure 6). This led to local residents and members of the Estuary Management Committee that covers Bellambi Lagoon to increase their lobbying for council to manage the erosion. Concerns ranged from the 3m+ erosion scarp being a public safety risk, to loss of dune vegetation and potential impacts on significant Aboriginal heritage items located in the dunes.

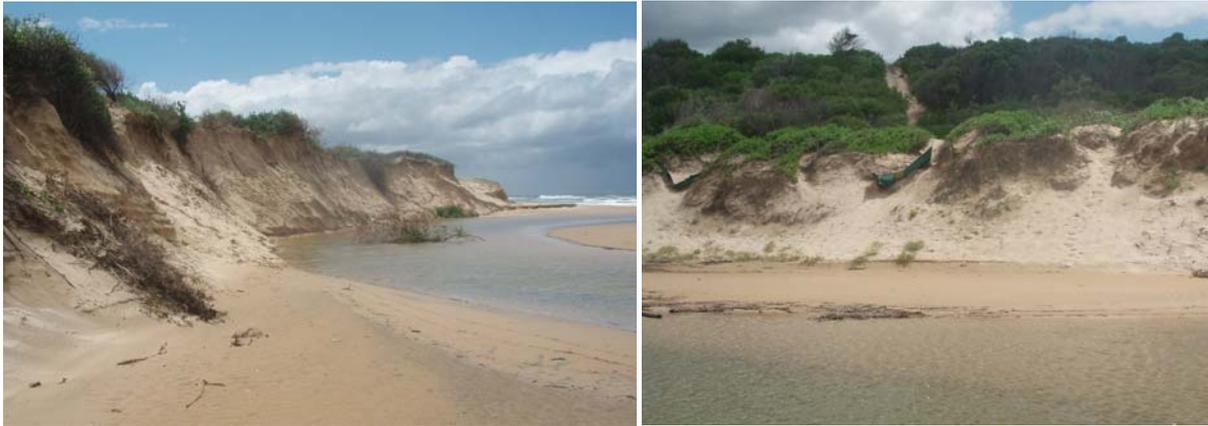
Figure 7: Entrance channel at the base of the northern dunes where channel flow scour has led to bank undercutting and collapse (left), and several access points along the middle of the northern dune scarp where dune blowouts have resulted (right).

As a result of the entrance channel being aligned at the base of the dunes, when the entrance is opened and in particular after heavy rainfall, channel flow scours the base of the dunes leading to undercutting and then dune collapse (Figure 7). This was likely to have been a large factor in exacerbating the erosion immediately prior to the DECC study, with 10 openings documented over the previous 8 months (DECC, 2008). Ocean wave attack during significant storms would also be contributing to further erosion of the dunes, which has been observed on a couple of occasions where storm waves have coincided with spring tides. Unrestricted access along the dunes and trails that lead up and down the current scarp have led to further destabilisation of the dunes, with windborne transport of sand resulting in dune blowouts at several points (Figure 7).

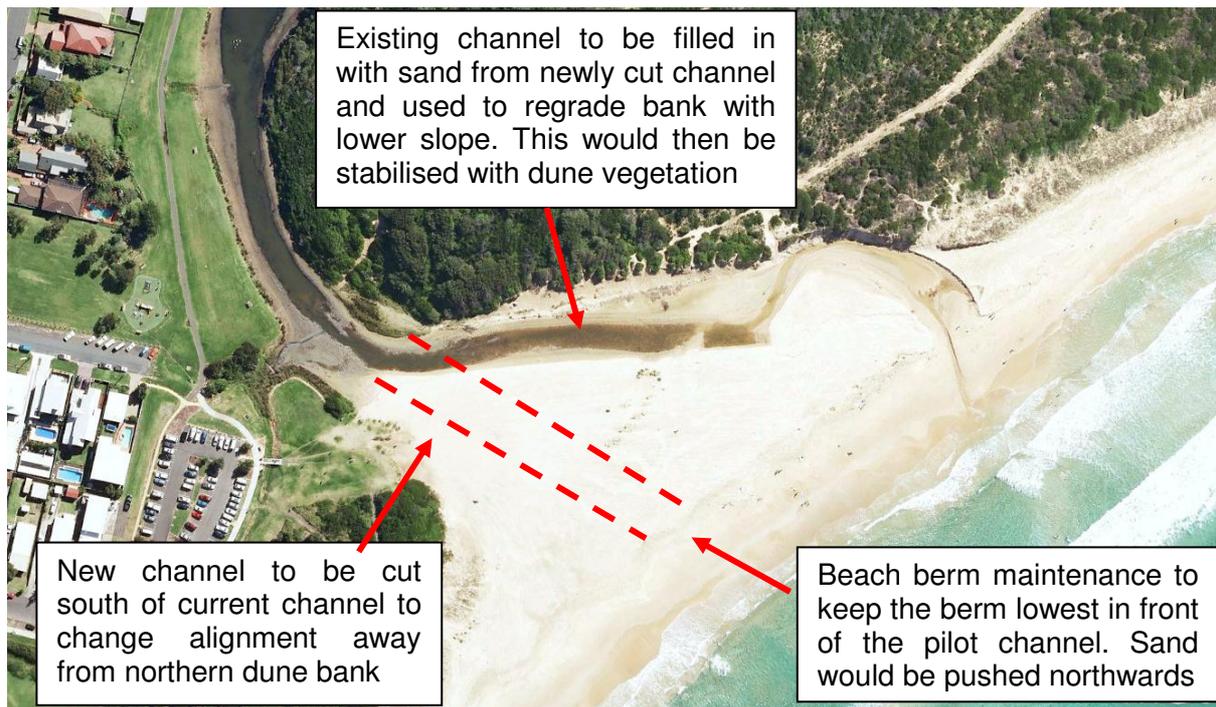
Figure 8: Concept diagram of the management approach taken, involving realignment of the entrance channel to a southerly position and berm maintenance as required.

The option that the community agreed on at the workshop was for the regular realignment of the entrance channel to a southerly position and berm maintenance as required (Figure 8). By manipulating the height of the entrance berm and periodically moving sand from the berm in front of the pilot channel to the north, the entrance was thought to be more likely to continue to breach in the southerly position, as this would be the lowest point in the entrance berm. Doing nothing was not acceptable to the community, but neither did they want a hard engineering solution that would transform the character of the area. It was agreed that the realignment option would initially be done as a trial to see if the channel could be maintained in a southerly position, and/or how long it would last in that position before it migrated back to the north with the potential to cause further erosion.

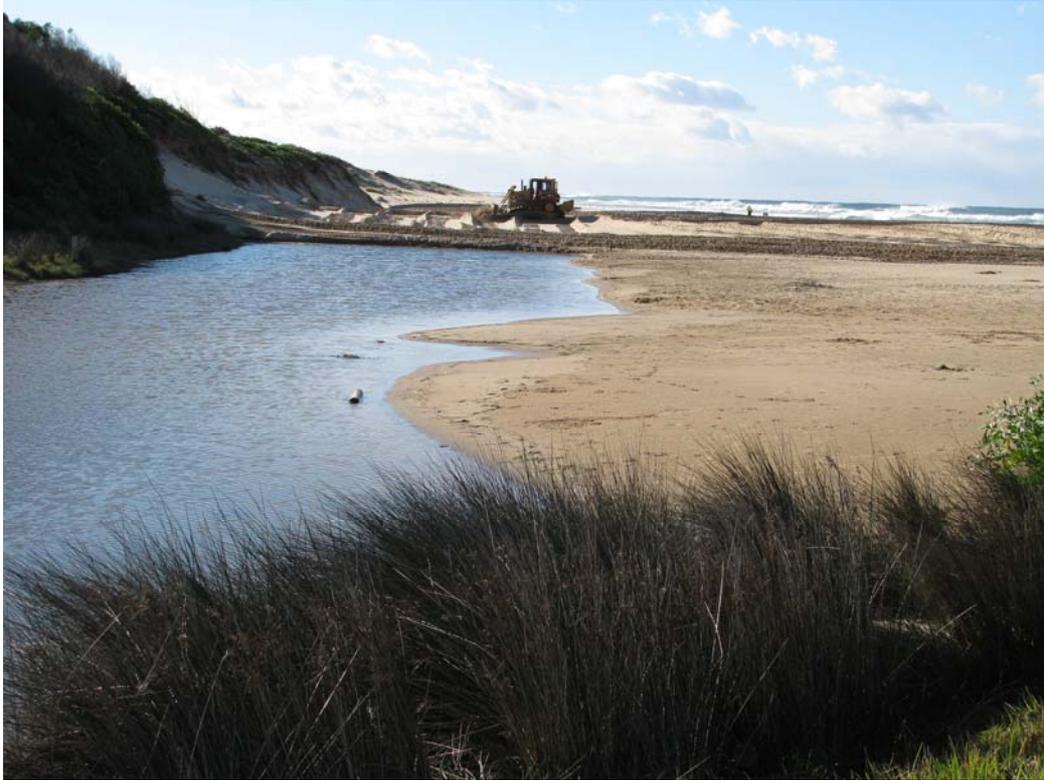
Figure 9: Initial entrance realignment works involving using a bulldozer to infill the northern channel (pictured) and create a pilot channel to the south (taken 10/6/2010).

The trial began in mid June 2010, with Council re-profiling the entrance area using a bulldozer by filling in the existing channel and pushing sand up against the eroding dune, then cutting a pilot channel to the south (Figure 9). Estuary Management Program grant funding totalling \$38,000 (matched by Council) was provided to assist with the trial of the entrance realignment works and inform the preparation of an entrance management policy, which is currently being prepared.

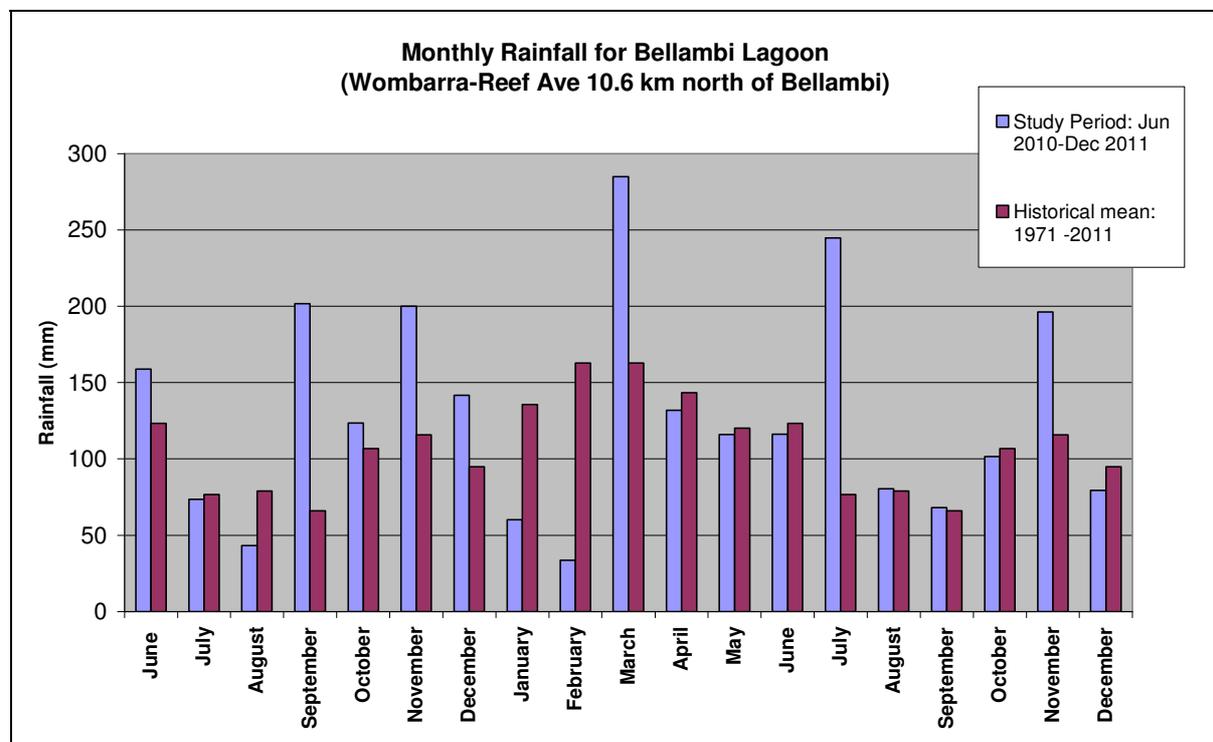
Figure 10: Monthly totals of rainfall of the study period from June 2010 to December 2011 in comparison to the monthly historical mean (BOM, 2011) (*Wombarra was used instead of

the rain gauge at Bellambi because there were a few months during the study period where the Bellambi gauge was off line and did not record rainfall).

20% greater than the average yearly total (Figure 10), this could have aided in maintaining the entrance channel in a desired southerly position.

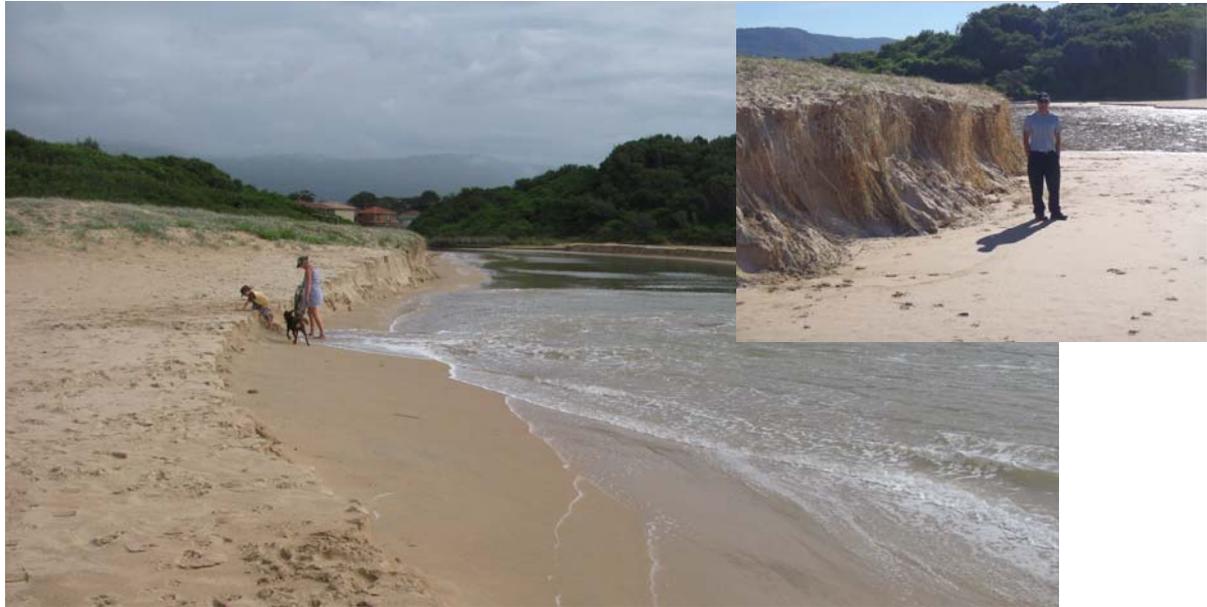
Figure 11: Bellambi entrance channel abutted against the southern dunes causing some minor erosion after a large flood discharge event (taken 22/3/2011). The top right photo shows the southern dune erosion that occurred after storm waves in combination with spring tides (taken 3/6/2011).

The southern dune erosion was likely assisted by the beach scraping event that council undertook over the 14-15th March. Council's bulldozer started scraping sand from the incipient dunes immediately south of the unvegetated berm area to build up the berm to the north. This would have resulted in the berm being lowered too far to the south making it easier for the entrance channel to migrate in this direction. Lowering of the berm area in this southern position would then have increased the southern dunes exposure to storm waves, causing further dune erosion.

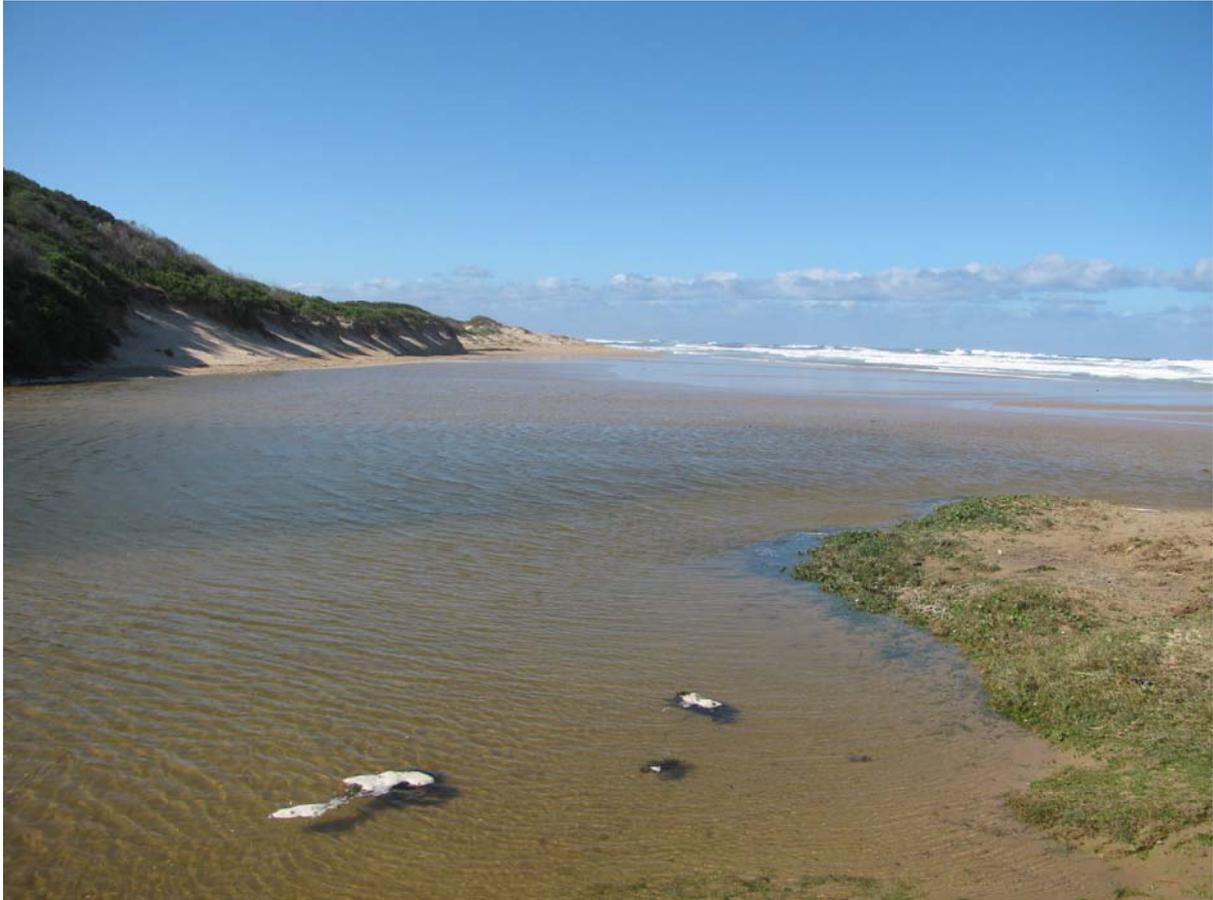
Figure 12: Bellambi Lagoon entrance channel and adjacent area after a substantial storm event (taken 13/8/2011), with overtopping still occurring at the time of photo taken.

This ability to infill entrance channels and redistribute sand was evidenced at Bellambi Lagoon on the 13th August 2010, two months after the initial channel realignment and berm profiling. Large seas with H_{sig} over 6m and H_{max} over 11m (Port Kembla Wave Rider Buoy) peaked during the top of a spring tide measuring at 1.87m AHD (from Fort Denison – the predicted tide was 1.6m AHD). This resulted in considerable berm overtopping and erosion, which completely filled in the pilot channel that was cut to the south (Figure 12). While no recognisable pilot channel leading to the back of the berm was evident, a deeper section was still maintained in the southerly direction at the point where the entrance channel bends to the east. This enabled council to make a relatively easy artificial entrance opening in a southerly position a couple of weeks later on the 2nd September to alleviate minor nuisance flooding.

The large waves in combination with the elevated ocean conditions also resulted in some very minor erosion on the northern dunes (most eastern section). However, without the works to infill the northern dune channel and beach scraping to move sand in front of the dunes and build up the berm in this area, it is likely that there would have been considerable erosion along this section of the dunes.

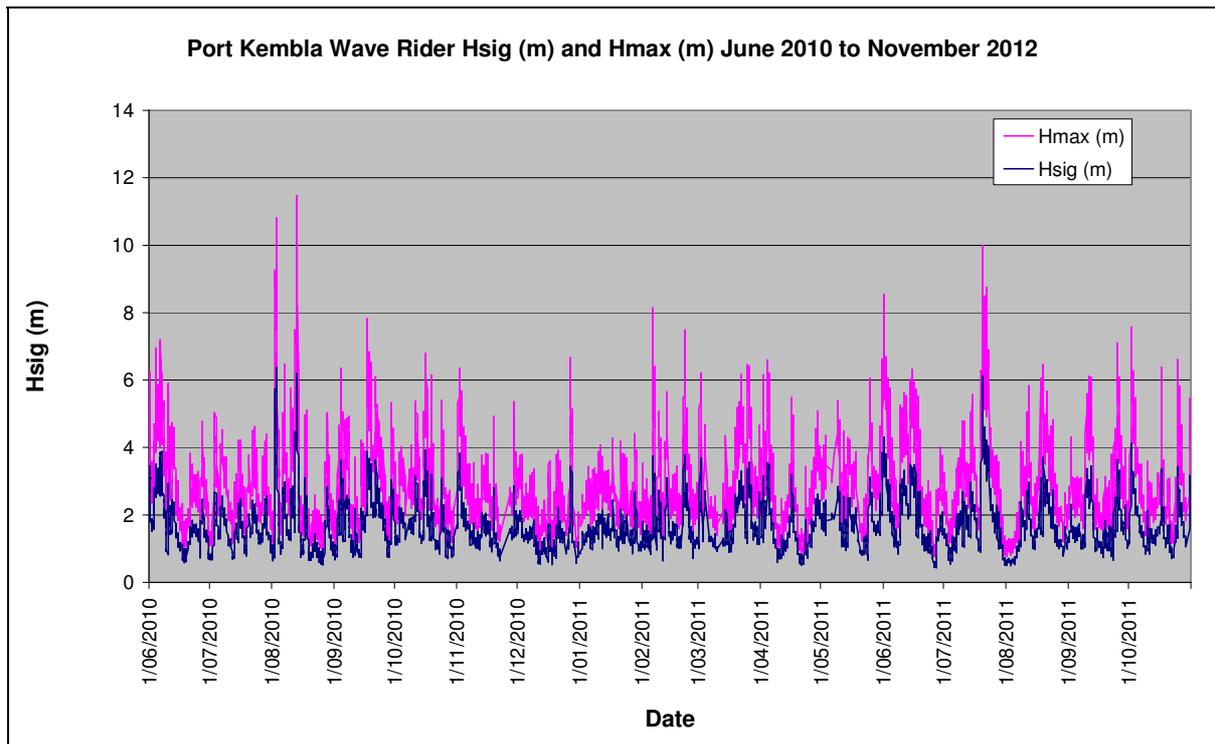
Figure 13: Significant wave height and maximum wave height recorded from the Port Kembla wave rider buoy over the study period. (Note: two periods of roughly 3 months data in total was supplemented from the Sydney wave rider buoy due to the Port Kembla buoy being offline). The NSW Office of Environment and Heritage is acknowledged as owner of the above data and MHL is acknowledged for the collection and provision of the data.

Overall, the study period was above average in terms of storminess, with a greater frequency and duration of minor to moderate storms (MHL, 2012). In total, three significant wave events (H_{sig} of 6m+ and H_{max} of 10m+) occurred between June 2010 and November 2011 (Figure 13). While all events led to overtopping of the berm, only the event on the 13/8/10 led to major redistribution of sand over the berm and channel areas. Analysis of wave statistics from the Port Kembla wave rider buoy (incorporating wave direction from the Sydney directional wave rider buoy) for all three events shows that the peak of the storm event on the 13/8/10 had a slightly larger wave period and had a more easterly direction compared to the two other storm events (Figure 14). However, the event on 20/7/11 had a much longer duration. While wave height, wave period, direction and duration can all have an influence on the impact of a storm on the coast, it is believed that the elevated ocean conditions in combination with large waves was the main reason why the storm event on the 13/8/10 had a greater impact on the entrance channel and surrounding unvegetated area. However, as this event was less than two weeks after the first major storm event, the beach and berm were likely still recovering and may have made overtopping easier.

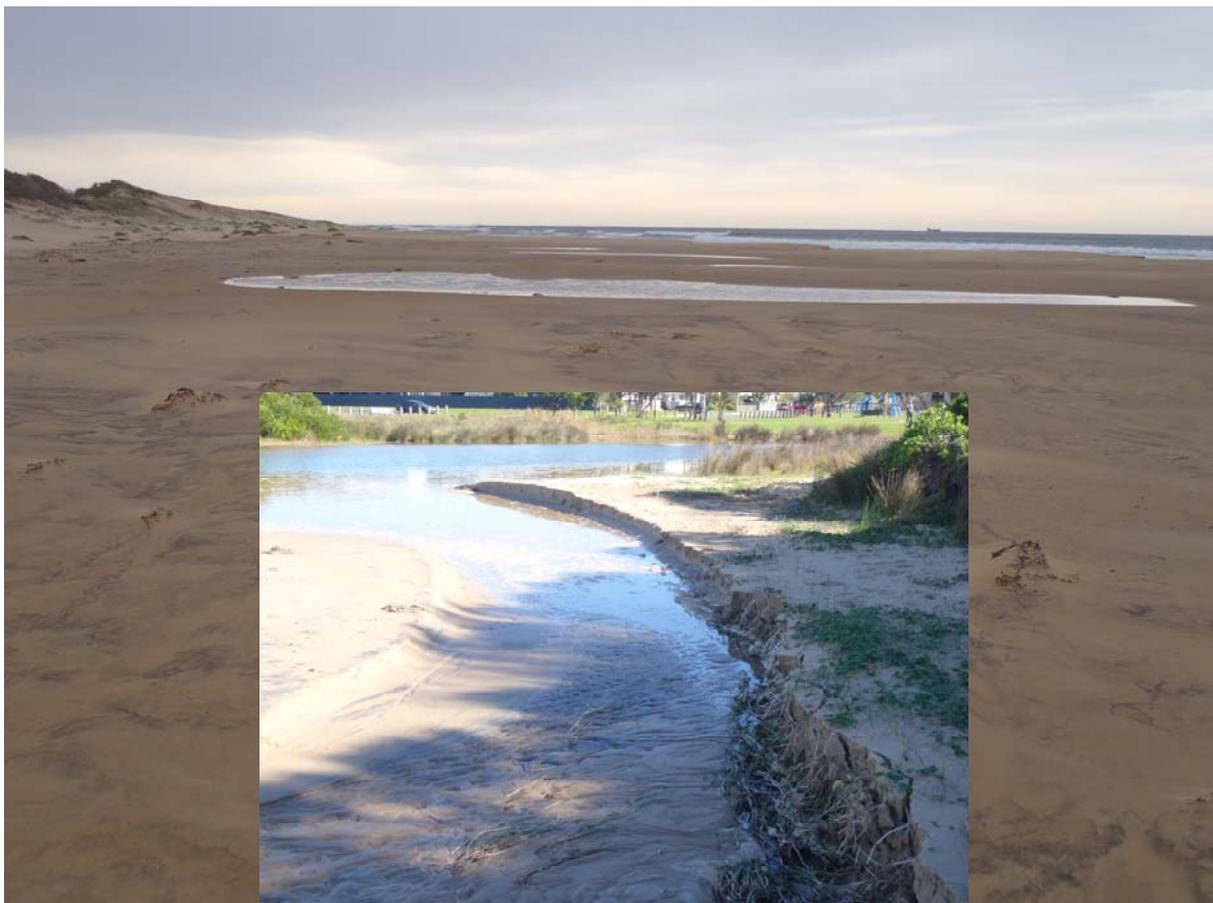
Figure 15: Ponding of water in low areas in front of northern dunes after berm overtopping from storm waves (main photo), with the backflow channel that formed as a result of the overtopping and water flowing back towards the lagoon (bottom photo).

Wave overtopping of the berm and backflow into the lagoon was observed on several occasions throughout the trial. The backflow into the lagoon led to a small channel being cut at the base of the northern dune, causing some minor erosion (Figure 15). Water was also perched in some low points on the unvegetated berm area for days after overtopping occurred. This was likely the result of the beach scraping works leaving some low points and some settlement following the scraping works. This situation could likely be resolved by building up these low points in future beach scaping events.

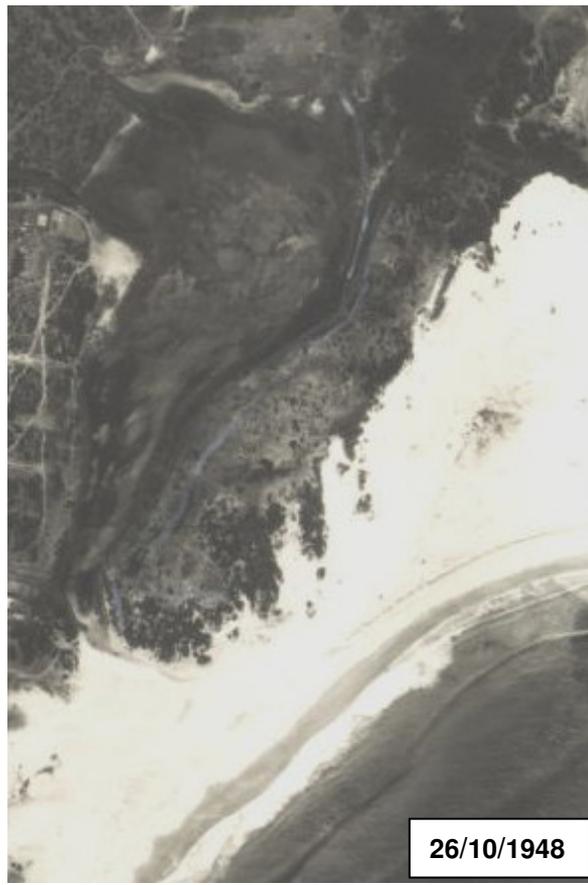
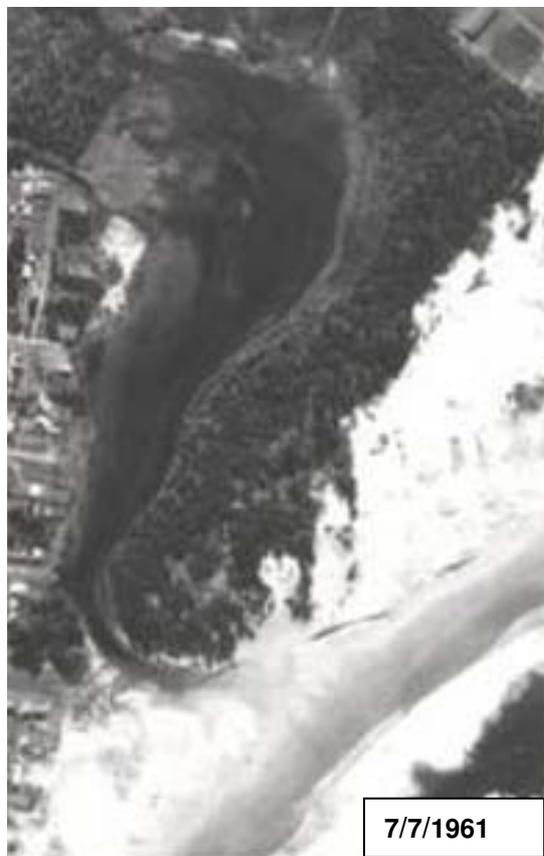
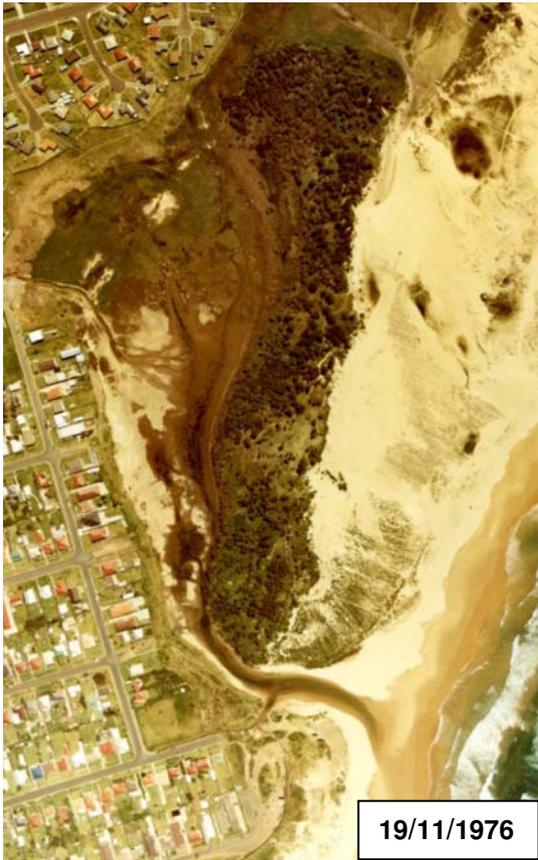
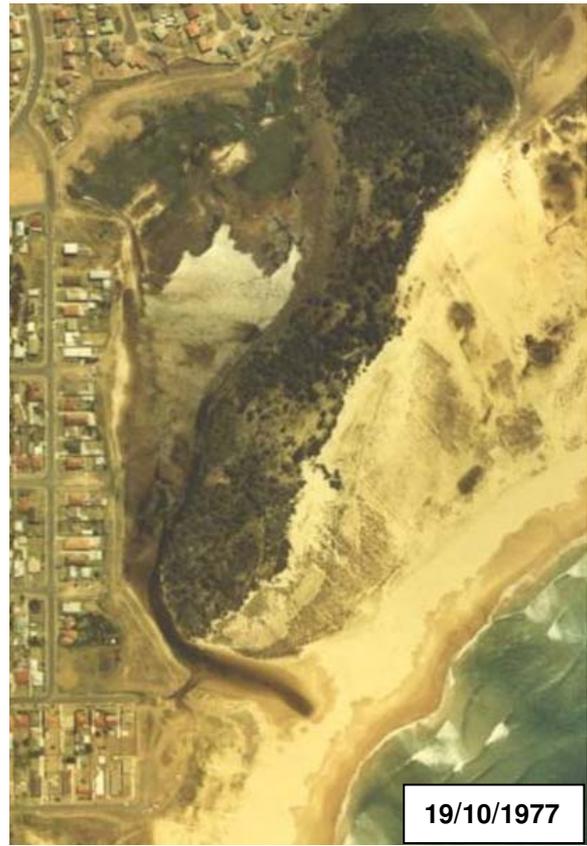
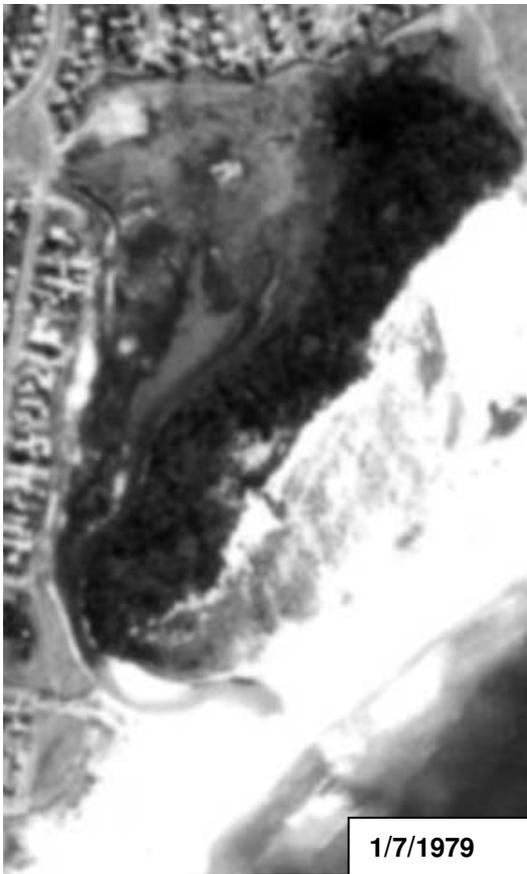
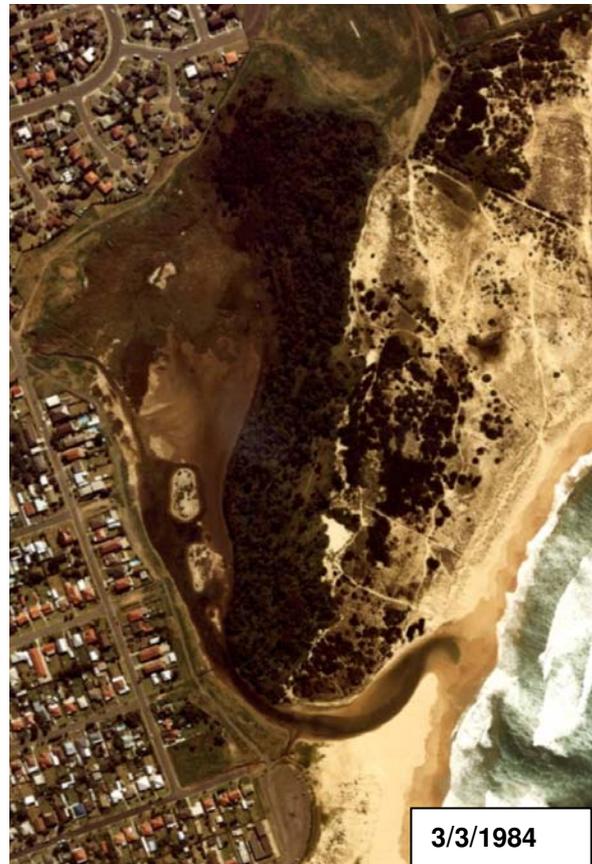
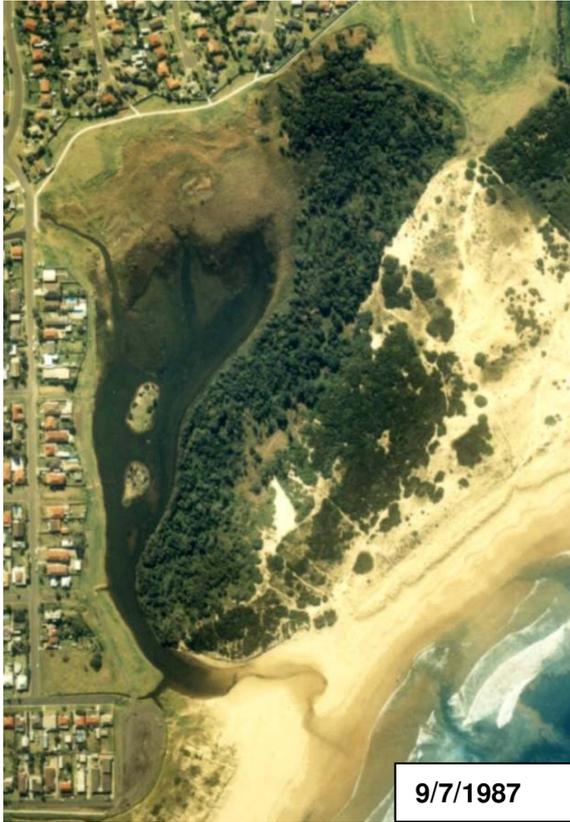
ATTACHMENT 1

The analysis of historical aerial photography showed that the dominant alignment of the entrance channel since the 1940's is at the base of the northern dunes (Attachment 1). There is only one period of time in the mid 1970's where the entrance channel was clearly located to the south. This is first indicated in the 1974 aerial photo and is more clearly depicted in the 1976 aerial photo. By 1979, the channel has migrated back to a northerly position alongside the dune, indicating that coastal processes caused the entrance channel to migrate to its northernmost position in about five years.
