# TOMAGO WETLAND REHABILITATION PROJECT: INTEGRATED, INNOVATIVE APPROACHES

## **Abstract**

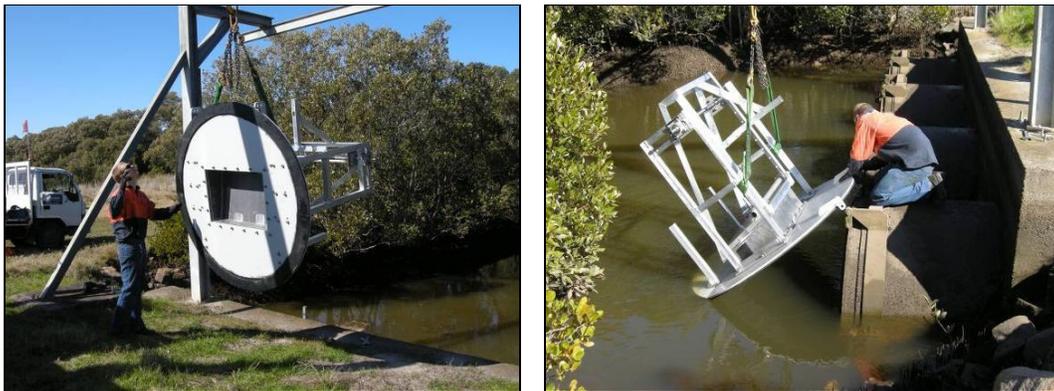
**Figure 2. SwingGates being installed**

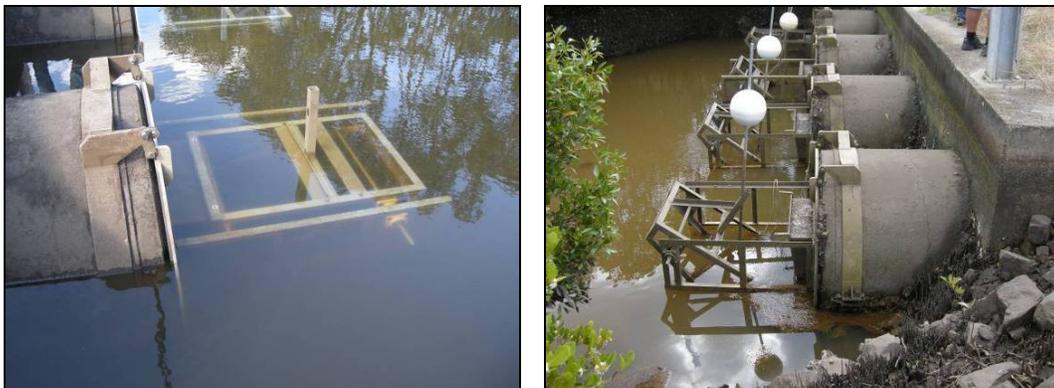
**Figure 3. Installed SwingGates in closed (left) and open (right) positions.**

Once this precautionary infrastructure was in place the four existing floodgate flaps on the eastern Tomago floodgates (previously one way flaps) were replaced with modified Swing Gates (Figure 2) in 2011. These allowed a limited amount of tidal flushing (up to 0.7m AHD) through the gates, before closing to prevent excess water entering the site (Figure 3).

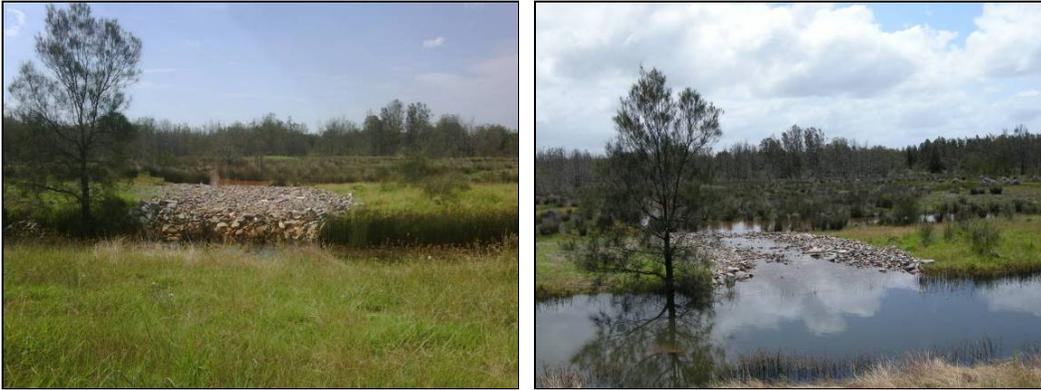
**Figure 5. Dish drain at low tide retaining relic drain water levels (left) and reconnecting relic channels at high tide (right)**

Other works were implemented as part of Stage 2 included earthworks to reconnect natural relic channels to the north of the ring drain and assist in delivery of tidal water to the centre of the wetland. This involved the construction of a rock lined dish shaped drain between relic wetland channels and the ring drain (Figure 5). Acid sulfate soil issues were a risk at this location and designs for these earthworks were in accordance with the Acid Sulfate Soil Management Guidelines (Robertson *et al*, 1998). Minimum existing water levels on the wetland side were maintained at 0.2m AHD to ensure oxidation of the ASS was avoided.

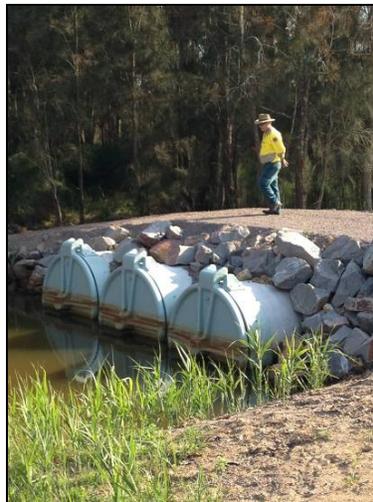
**Figure 6. Stage 3 Eastern culverts and floodgates**

In 2012 the final stage (Stage 3) of the proposed works was undertaken with funding from the Hunter Central Rivers CMA and NSW Parks & Wildlife. This involved the construction of a new set culverts with one way flaps on the ring drain approximately 2km upstream (to the north east) of the eastern floodgates (Figure 6), and a 650m low level levee bank north of the new culverts to approximately 1m AHD. This infrastructure isolated properties outside the National Park boundaries from tidal waters. Once these works were completed, the flaps installed on the ring drain culverts during Stage 2 were permanently opened to reconnect the ring drain to tidal flushing and permit flows up to the north-eastern parts of the wetland.
