WINDING BACK THE CLOCK IN DUNE MANAGEMENT AT WOLLONGONG

A Beardsmore¹, P Gangaiya^{1,2}, T Miskiewicz¹

¹Wollongong City Council, Wollongong, NSW

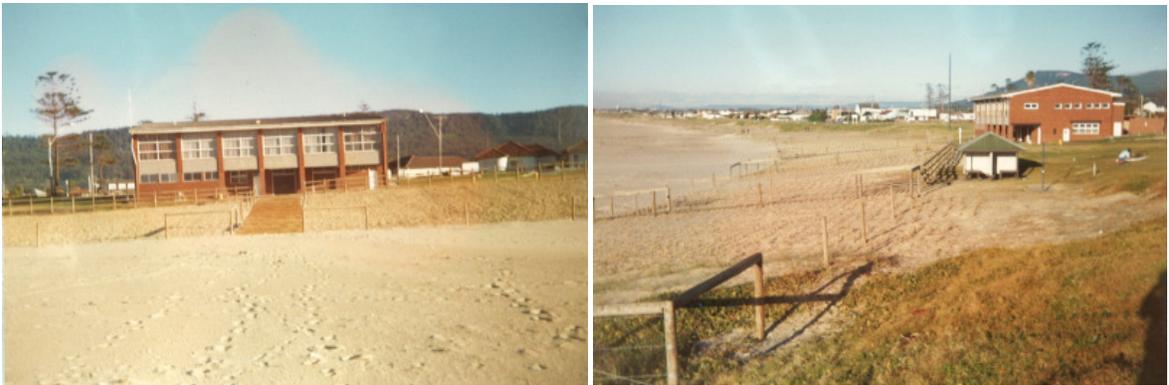
Figure 1. Photographs showing the dune restoration works carried out at Woonona Beach in 1986.

In 1986, Council in conjunction with NSW Public Works and the Soil Conservation Service undertook dune restoration work at a number of beaches, including Woonona Beach. Sand from the beach berm was moved to fill in lower areas at the back of the beach. A 20-40 m wide stretch of back beach was then fenced and planted (Figure 1). Species planted are listed on Council's records as *Acacia longifolia*, *Acacia sophorae*, *Banksia*, *Leptospermum laevigatum*, Marram Grass and *Spinifex*. The original dune restoration vegetation became well established, but had also spread up to 30 m seaward beyond the original planted zone (Figure 2). The decrease in area of sandy beach available for recreation was of concern to some of the community. As well as the seaward growth of the vegetation, dune heights had increased, leading to obstructed sightlines from the surf lifesaving and lifeguard viewing areas, creating a public safety issue of concern to the community.

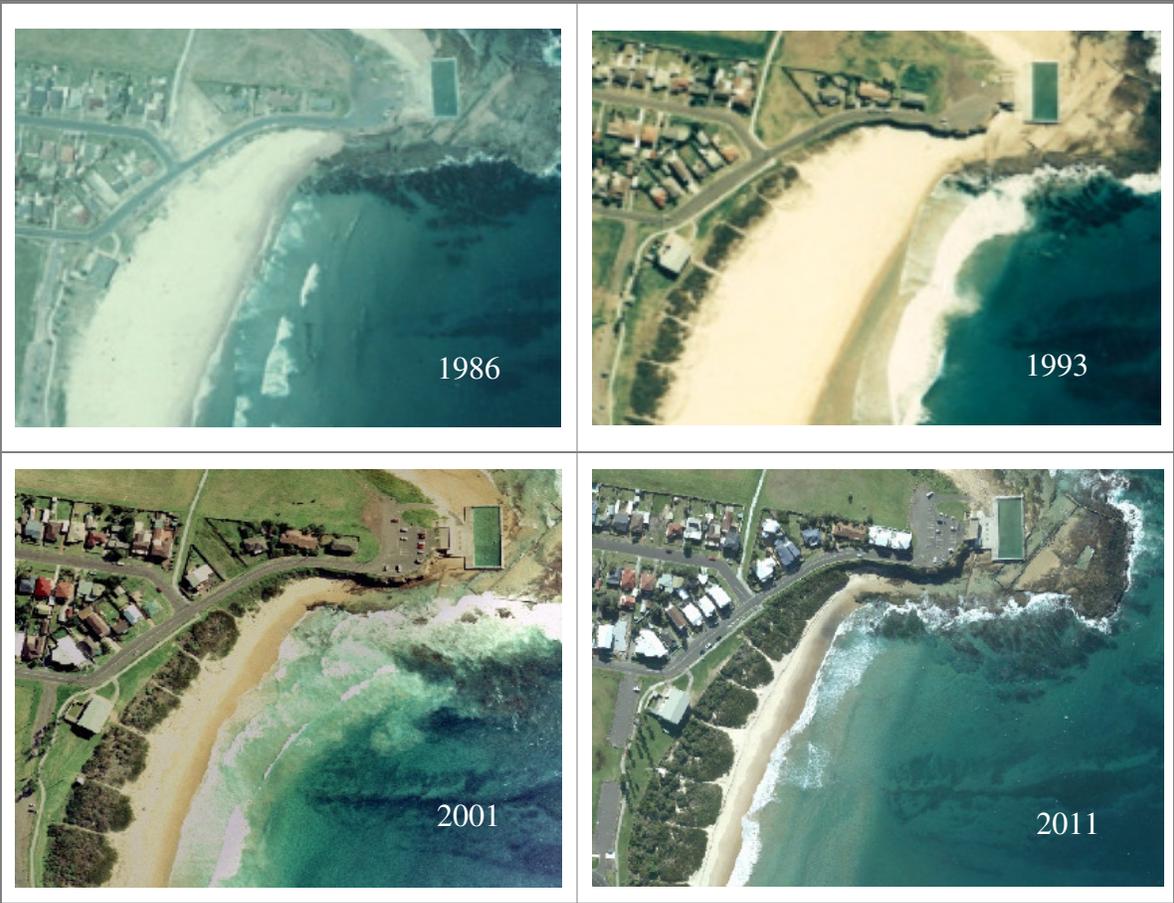
Figure 2. Aerial photographs of Woonona Beach showing vegetation spread over time (not georectified; for illustrative purposes only)

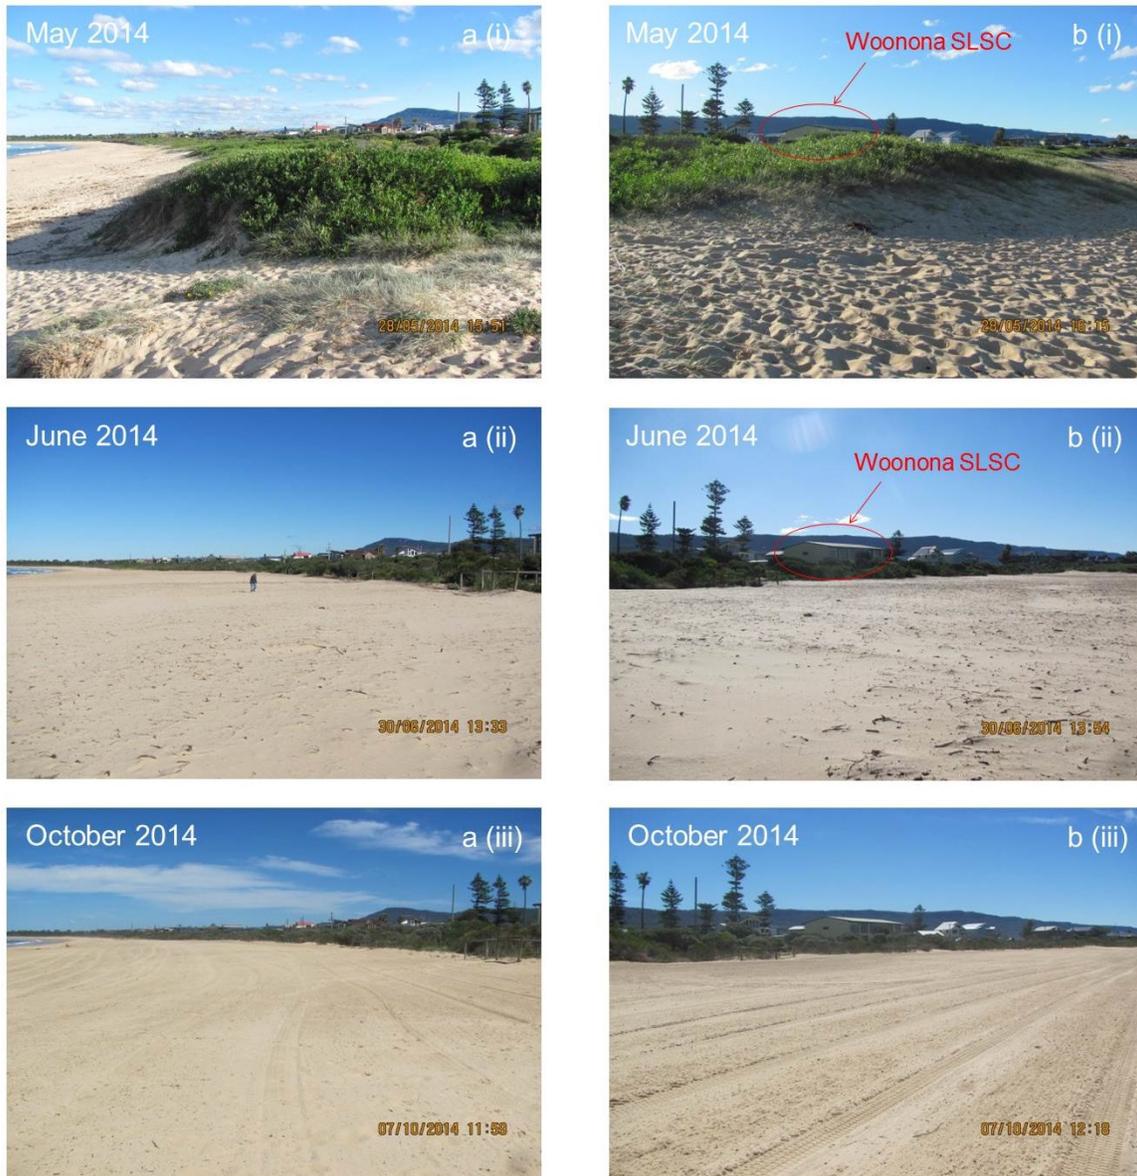
Figure 3. a) View of Woonona Beach from the north (a) and south (b) before reshaping (i) 10 days after (ii) and four months after (iii)

On-ground works were undertaken by contractors and took three weeks including a pre and post works survey. During this time, four beach access ways were closed and the beach and dune area fenced off from public use. Vegetation (*Acacia longifolia* subsp. *sophorae*) removal was undertaken by two bulldozers. A shaker bucket attachment was used to sift roots and other plant debris from the sand. The beach was then regraded by excavator. Figure 3 shows the beach before and after the vegetation removal and reshaping.

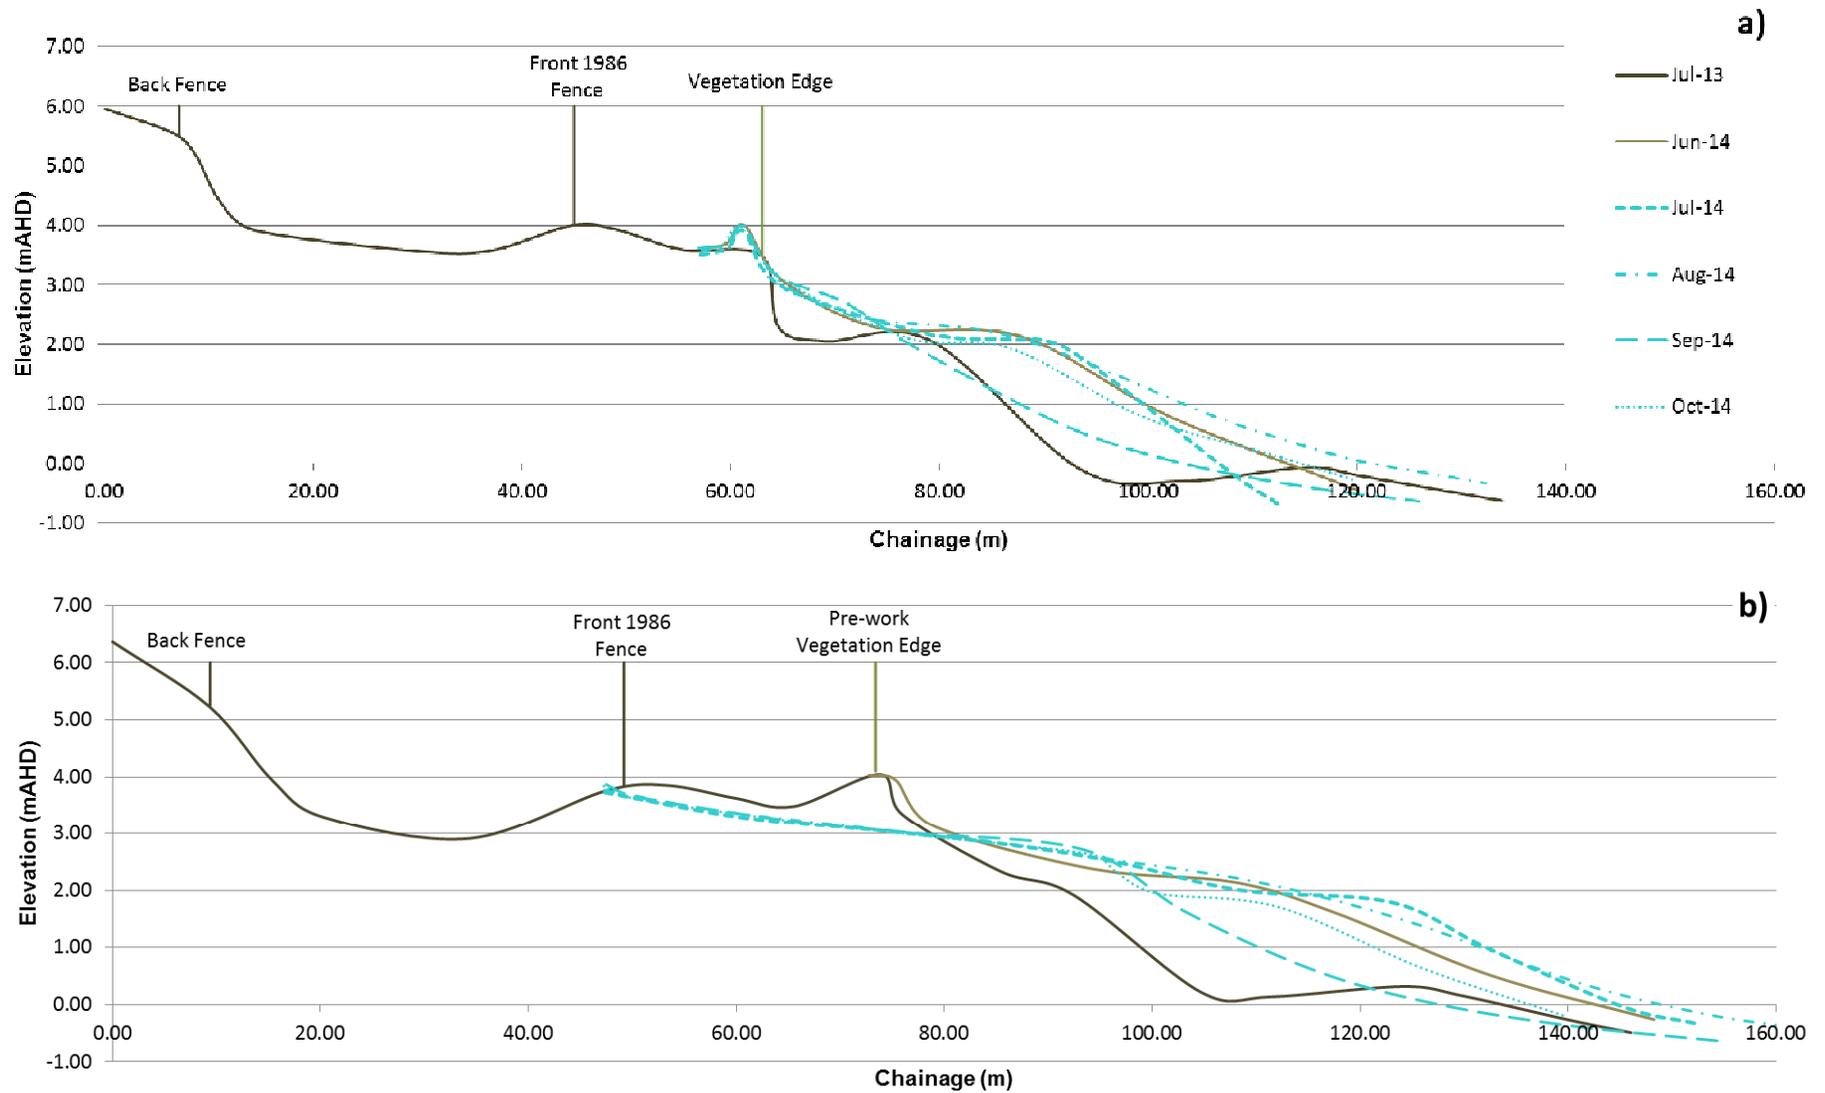
Figure 4. Transects through Woonona Beach in the non-worked (a) and worked (b) area for selected months

Council has been monitoring dune transects monthly within and adjacent to the project site since July 2013 as part of its broader Dune and Beach Monitoring Program. Three transects are located within the reshaped area, one on the southern edge, and one 50 m to the south of the site. Figure 4 shows a transect within the reshaped area and the one to the south. The June 2014 survey was undertaken a few days before the reshaping work and the July 2014 profile three weeks after completion.

In the four months following the completion of the works, the mean beach width, defined as the distance to the 0 m AHD mark (i.e. mean sea level), has increased by about 20 m in the works area, as against about 10 m in an adjacent non-worked area. The on-ground works also reduced the foredune height in the works area by about 1 m, and there has been no change in this since the works. This suggests that the additional beach width achieved in the works area by moving sand to the lower beach and the reduced height of the foredune are continuing to be maintained, at least over this time period. These transects will continue to be regularly monitored to determine the longevity of the project.
