# COFFS HARBOUR NORTHERN BREAKWATER – NOT YOUR AVERAGE UPGRADE

**R Main<sup>1</sup>**, A Hartley<sup>1</sup>, C Dengate<sup>2</sup>, E Rowe<sup>2</sup>, M Blacka<sup>3</sup> <sup>1</sup>NSW Department of Industry - Lands, Newcastle, NSW <sup>2</sup>GHD, Sydney, NSW <sup>3</sup>WRL, UNSW Australia, Sydney, NSW

This paper provides a summary of the challenges encountered during the development of the Northern Breakwater Upgrade Project as well as the innovative design and consultation solutions employed to deliver successful project outcomes.

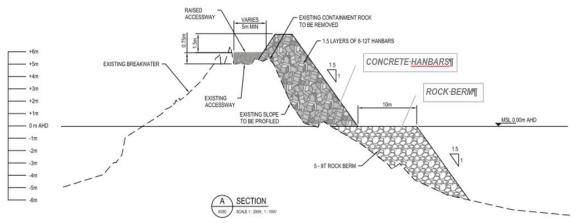
Figure 2 Typical Section of Proposed Upgrade (Option 8)

The preferred Option 8 – a composite armoured berm upgrade – gernerally consists of a layer of concrete Hanbar armouring which will be constructed on top of a newly constructed rock berm extending from the seaward side of the existing structure at mean sea level. The crest of the breakwater will be widened and raised along the eastern portion of the structure.

Pedestrian views to the ocean will be retained with Hanbar heights ranging from 0.5 m to 1.5 m above the crest.

The rock berm will force waves to break seaward of the existing structure, whilst the concrete Hanbar armouring will increase the structure's freeboard above sea level and the absorption of wave energy, thereby minimising the amount of wave energy reaching the top of the structure. This will result in reduced frequency and magnitude of overtopping at the crest of the breakwater, and improved safety for those accessing Muttonbird Island and the Coffs Harbour Marina.

To construct this option, trucks will transport and tip the rock armouring for the berm into place from the existing crest structure before a long reach excavator would undertake rough profiling of the berm. Depending on the plant/equipment available, an alternative methodology would involve construction of an interim access berm at approximately +2 m AHD, from which the rock for the berm would be placed and profiled. The Hanbar armour units will be stockpiled at the existing casting yard located on the southern foreshore of Coffs Harbour, with the Hanbars transported to the northern breakwater via road. Trucks will then reverse along the crest of the breakwater where the Hanbars will be unloaded prior to their placement on the face and crest of the breakwater by an awaiting crane.

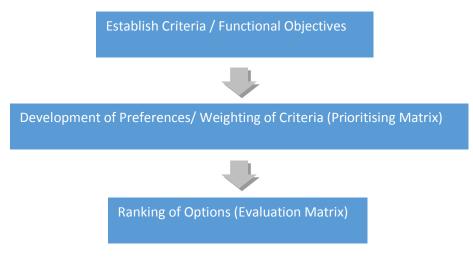
Figure 3 Option Evaluation Process

An overview of the evaluation process undertaken is shown in Figure 3 below and described in detail in the following sections.

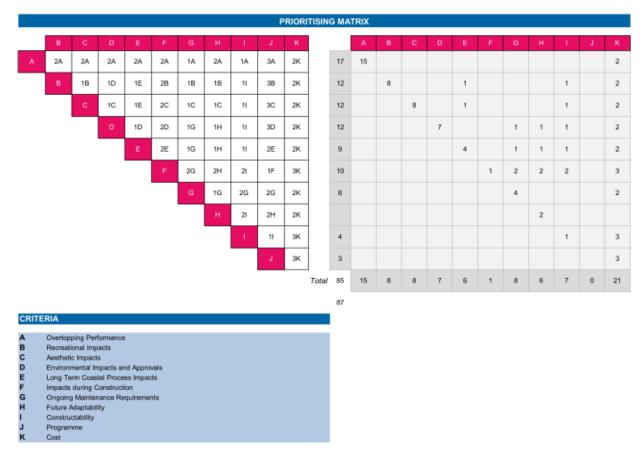
Figure 4 MCA Prioritising Matrix

For example, criterion A (Overtopping Performance) was rated as more important than J (Programme) and was given 3 points. In contrast, B (Recreational Impacts) was rated only slightly more important than C (Aesthetic Impacts) so 1 point was allocated for B.

The resulting matrix is shown in Figure 4 below.

From the prioritised matrix the scores for each criterion were subsequently added to determine the score for each. Weighting of the criteria was then calculated on the following basis:

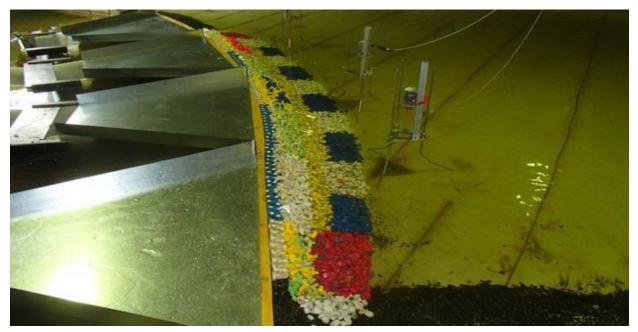
Figure 5 Physical Modelling of the Preferred Primary Upgrade Option

The physical model was validated by assessing the breakwater overtopping in areas where there is known to be a major hazard (e.g. adjacent to the marina). This validation was based on qualitative visual comparison of historical data, videos and photos of specific storm events at the existing breakwater, and observation of the physical model under the same scaled conditions. This included verifying the location and intensity of the overtopping in the model in comparison to the photographic records.

The stability of the primary armour, crest specific armour and rock berm armour was investigated and assessed under 10 year ARI (HAT) and 100 year ARI (HAT + SLR) wave conditions. In general, both design iterations were considered stable and suffered very low overall damage<sup>1</sup> (less than 1%). The rock berm was observed to exhibit some slight reshaping behaviour but with overall negligible damage. It was observed that the reduced 5m width rock berm resulted in slightly higher damage to the Hanbars and rock berm when compared to the 10m berm width investigated.

proposed upgrade was observed to significantly lower the average overtopping rates compared with the existing structure. Overtopping rates were reduced to below 3 L/s/m for the 10 year ARI HAT event, and to below 10 L/s/m for the 100 year ARI (HAT + SLR) wave conditions confirming that the proposed upgrade would reduce the risk of damage to vessels within the marina and limit the hazard to a pedestrian risk only.

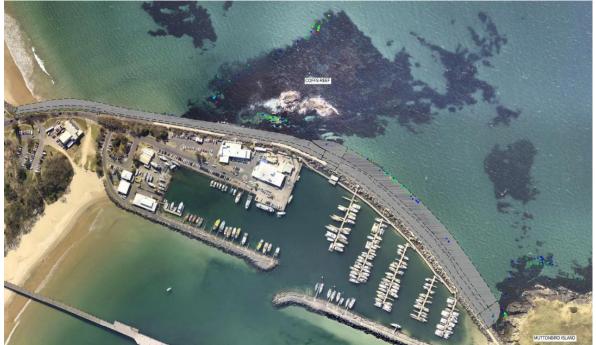
Figure 6 Extent of Initial Design and Relative Location of N. lophocladia

Since the targeted surveys conducted in April 2015, further targeted surveys were undertaken by Elgin Associates in September and October of the same year. These surveys indicated that there were a significant number of the species present on, and in the vicinity of, the existing structure as seen in Figure 6 below.

With identification of the *N. lophocladia* seen in Figure 6, a revised breakwater upgrade design was developed to minimise the impacts of the upgrade works on the *N. lophocladia* through reduction of the upgrade footprint. A plan view of the final breakwater design can be seen in Figure 7.

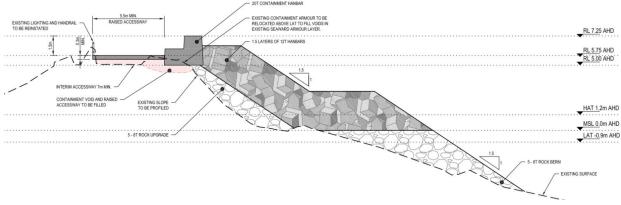
Figure 8 Typical Cross Section for Final Design

The greatest estimated number of individuals of *N. lophocladia* at risk of being directly impacted by the upgrade works are located at the toe of the central portion of the existing structure. To eliminate the direct impact of the upgrade works on the alga in this region, the upgrade design was altered, narrowing the 5-8 tonne rock berm at MSL to 5 m and bolstering the design with the placement of 1.5 layers of 12 tonne Hanbars atop this berm. This design constrained the upgrade within the footprint of the existing structure in the vicinity of the N. lophocladia and allowed for a buffer between the approximate locations of the alga and the proposed works. Consideration of the location of the existing N. lophocladia as well as of the coastal engineering advantages and disadvantages of the final design, led to the final design being proposed. Figure 8 below shows a typical section for the Final Design in the vicinity of the greatest estimated number of individuals of *N. lophocladia*.

- Sections of the proposed toe design were modified to create a complex toe profile which will promote formation of sand scour holes and provide increased habitat opportunities for *N. lophocladia*. This was achieved by including 5-8T rocks on the seaward side of the toe at 5 metre intervals along the breakwater.
- A 500 mm thick scree of greywacke cobble (sizes 100 250 mm and ~10% ~400 mm) was included in order to maximise the creation of the sand/rock edge habitat considered suitable for *Nereia lophocladia* in areas where the species has not been recorded. The scree was designed to cover the seabed extending between 2 m and 5 m from the toe of the structure.

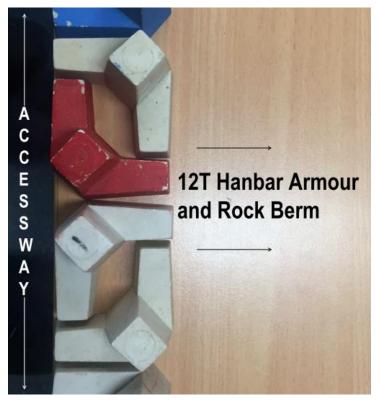
Figure 9 Pattern Placement for 20T Containment Hanbars

The pattern placement of these units will be in a similar fashion to that undertaken for the physical modelling, shown in Figure 9 below.

Through the eastern section, to maximise coastal protection and the stability of the structure, whilst minimising the impact to views for pedestrians using the breakwater crest, customised 20 tonne Hanbars were determined to be the most appropriate unit for crest containment. These Hanbar units were customised to ensure that pedestrian views from the crest of the breakwater are maintained. The Hanbars are of the same dimension as a standard 22 tonne Hanbar unit, with the exception of the chimney, which was shortened to reduce the containment impact on pedestrian views. The 20 tonne containment Hanbars will be pattern placed on top of a level footing composed of gabion sized rock and supported by the lower level Hanbar units. This level footing will ensure the following:

- the shortened chimneys are placed upright to minimise containment disrupting pedestrian views
- the Hanbars provide an organised and consistent aesthetic and informal seating arrangement for users of the breakwater
- effective interlocking of units can be achieved to enhance stability
