COFFS HARBOUR BOAT RAMP – LONG WAVE DATA COLLECTION TO EVALUATE PERFORMANCE OF BASIN EXTENSION WORKS

M Kulmar¹, I Jayewardene¹, M Glatz¹, M Robertson²

¹NSW Government, Manly Hydraulics Laboratory (MHL), Manly Vale, NSW

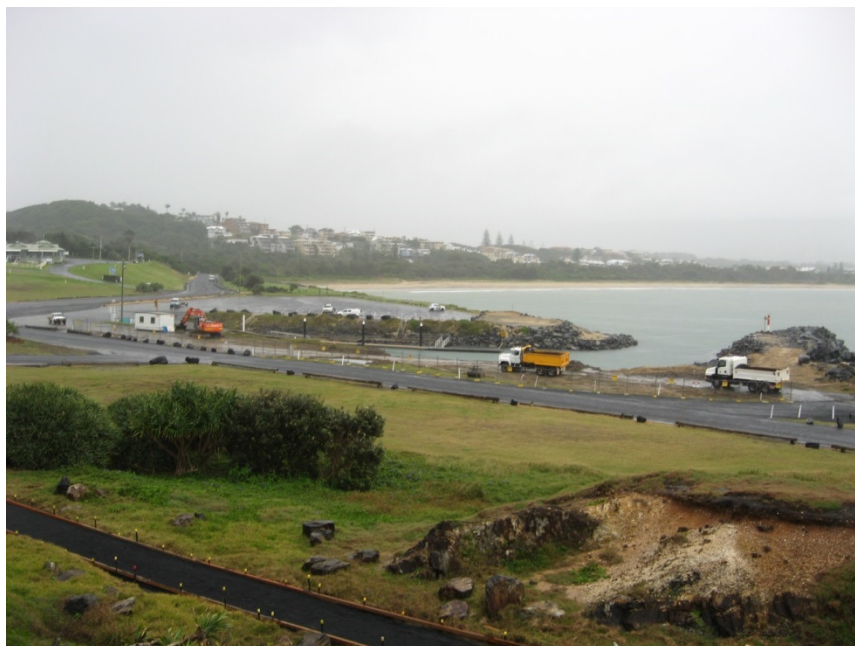
Photo 1 Site prior to construction works – 21 May 2015

The construction works footprint is wholly within the fill material utilised to establish the South Coffs Island connection with Corambirra Point that was completed in 1914. It was estimated that approximately 8000 cubic metres of material would be excavated to extend the basin with some material being used to construct the basin batters and the porous dissipative beach within the extended basin. After site preparation works construction of the basin extension commenced on 21 May 2015 (**Photo 1**).

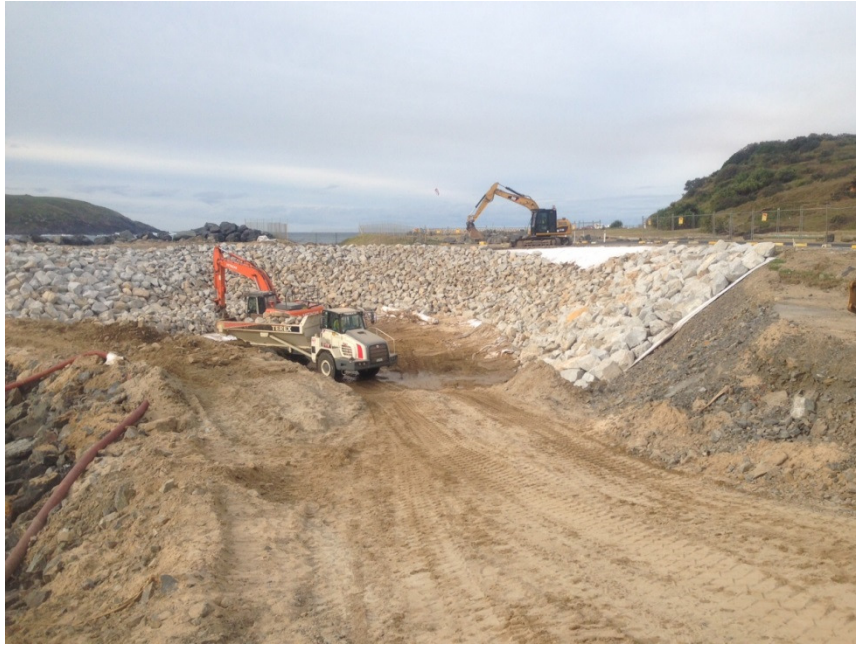
Photo 2 Construction in progress – 15 July 2015

Excavation continued to design levels and geotextile fabric and rock armour were placed around the perimeter and floor of the extended basin (**Photo 2**). The final excavation took place with the removal of the rock bung on 27 July 2015.

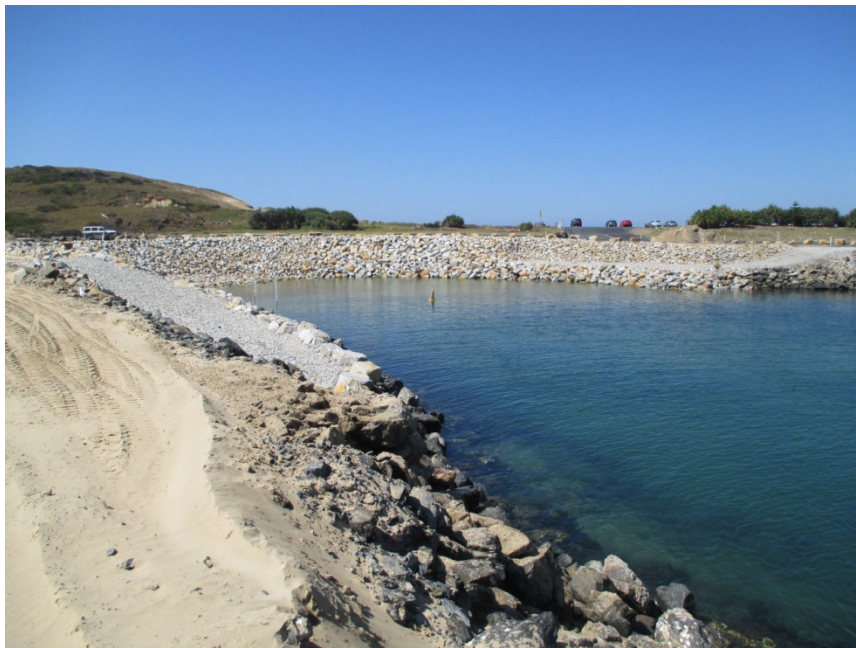
Photo 3 Completed basin extension – 3 October 2015

To assist with future clearance of sand entering the boat ramp basin two horizontal maintenance pads were included on either side of the extended basin to support long-reach excavators that will be utilised for such operations. The construction works were completed on 4 August 2015. **Photo 3** shows the completed basin extension in October 2015.

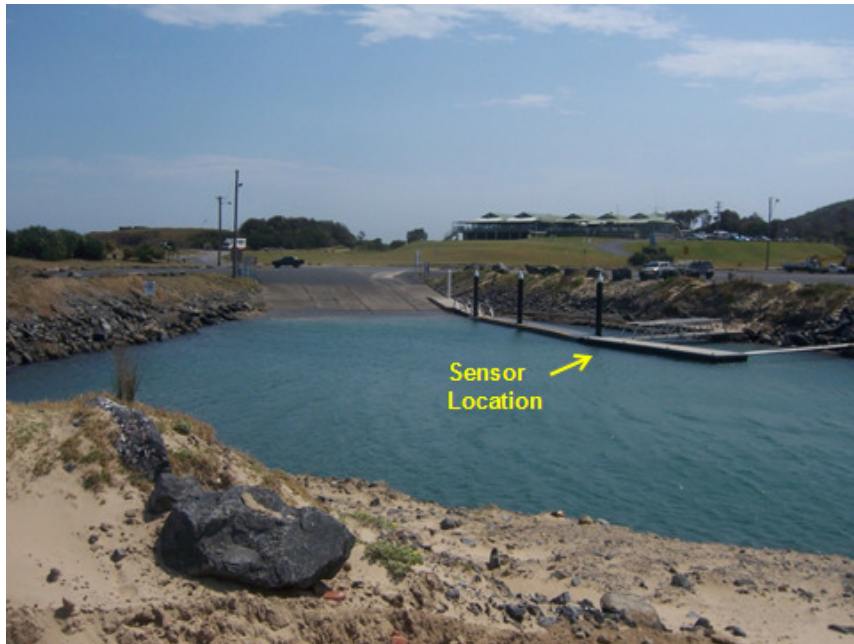
Photo 4 Wave sensor location in boat ramp basin

Suitable subsurface pressure transducer wave monitoring instruments were used to gather wave and surge data in the boat ramp basin. A data recording regime was designed to collect information on the wave energy spectrum to identify the range of wave and surge conditions that prevails in the boat ramp basin. The instruments were fixed to one of the pontoon support piles below low tide level about 1 m above the

seabed to ensure that wave conditions were monitored for all water levels and the influence of tide level on wave action could be assessed (**Photo 4**).

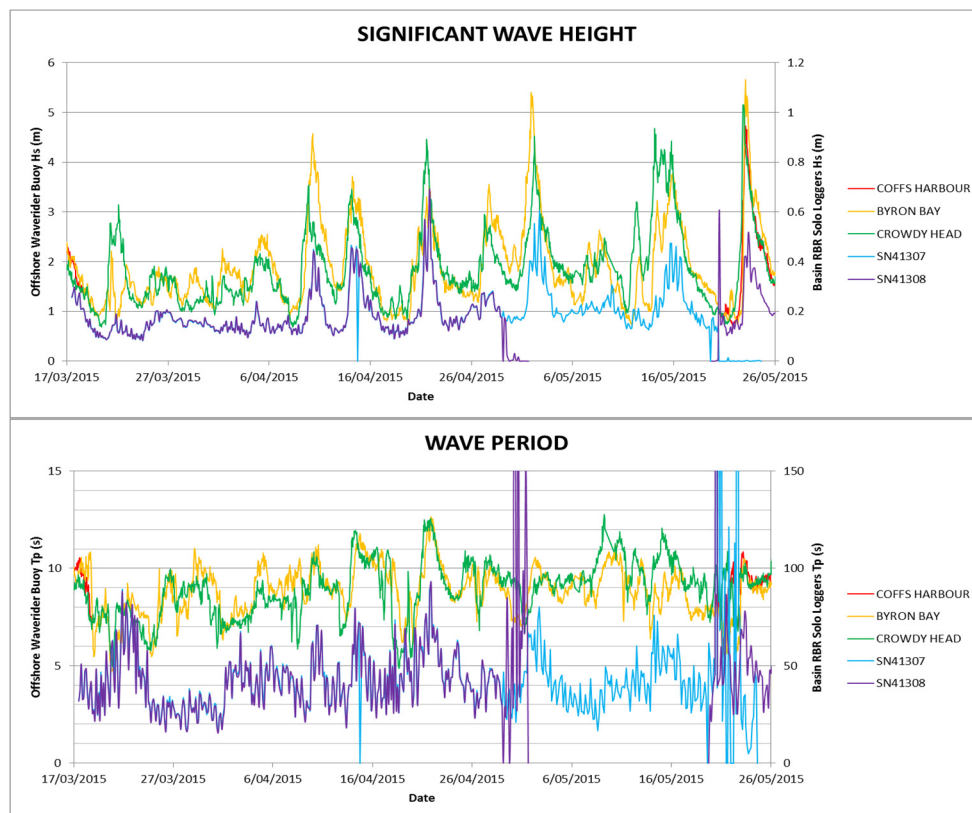
Figure 4 Comparison of offshore and basin wave conditions – Before basin extension

Selected samples of the offshore wave conditions and the coincident conditions recorded in the boat ramp basin before the extension works and after the basin extension completion are presented in **Figure 4** and **Figure 5** respectively.

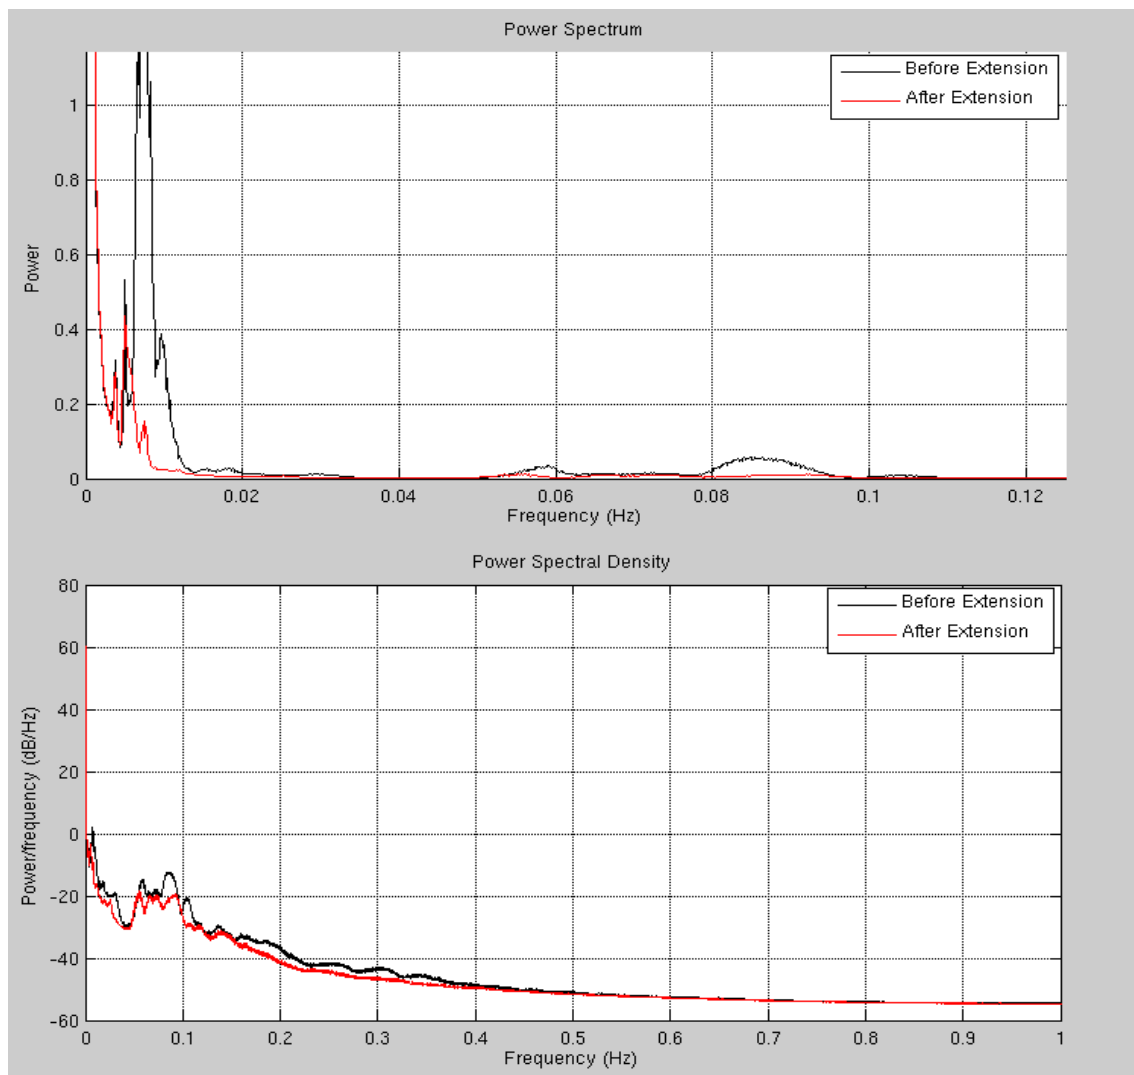
Figure 6 Power spectrum (top) and power spectrum density (bottom) based on recorded pressure data (RBR Solo S/N 41307)

For each selection window, two analyses were carried out between the data from before and after the basin extension works. The first analysis sought to detect change in energy present within the basin during comparable offshore wave event categories. The total power (synonymous with energy) of the entire RBR solo datasets before and after the basin extension works was calculated. The distributions of total power arising in before and after basin extension events were then overplotted on frequency graphs. Hence **Figure 6** presents the power spectrum and power spectrum density based on the pressure data for Deployment 1 (before basin extension) and Deployment 2 (after basin extension) for RBR solo logger S/N 41307.

The plots presented in **Figure 6** indicate a reduction in wave energy after the basin extension was completed. However, this conclusion is not definitive since the number of events before and after the extension of the boat ramp basin was different. Furthermore, as illustrated in **Figure 7**, using the before basin extension offshore Hsig record as the baseline (red line), the offshore Hsig record was lower during the basin construction works (yellow line), and even lower after the completion of the basin extension (green and blue lines).

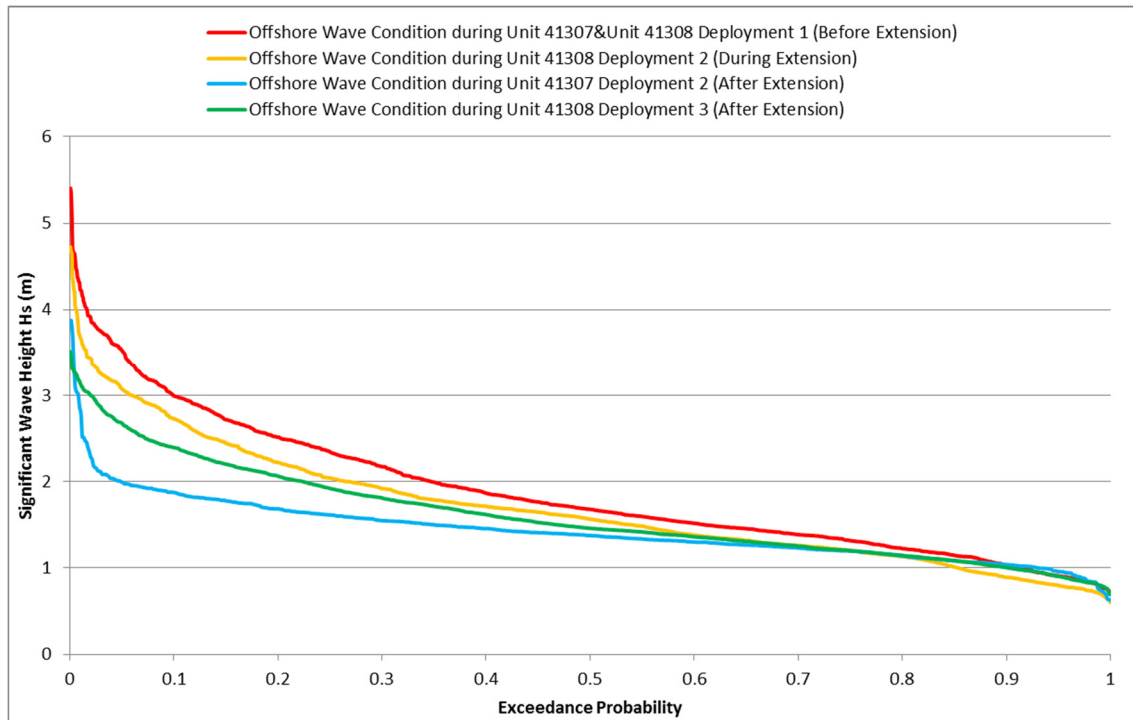
Figure 7 Offshore Hsig exceedance probability comparison – Before, during and after basin extension works
