CASE STUDIES IN DAMAGE AND REPAIR STRATEGIES FOR TRAINING WALLS AND BREAKWATERS ON THE NSW COASTLINE POST-JUNE 2016 STORM

Abstract

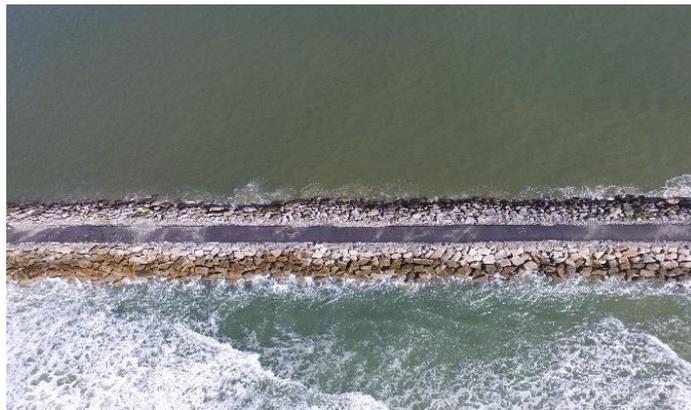
**Figure 5a Clarence north training wall prior to 2016 storm
(drone photo courtesy Dol – LaW)**

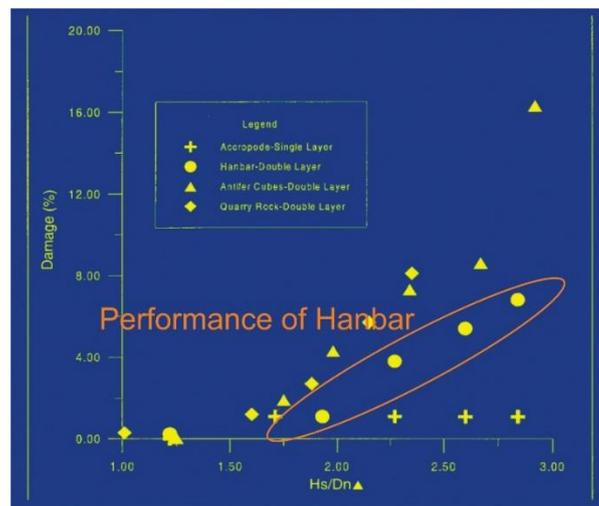
Figure 10a indicates the relative performance of concrete armour units in comparison with rock armour as modelled at MHL for the Ballina south head, where Hanbar units replaced existing rock armour in 1997 (MHL 1997). This structure was repaired in 2007 utilising 7t armour and in 2015 utilising 12t armour. The Ballina south head was relatively undamaged during the June 2016 storm, indicating that timely repair had prevented damage. The Coffs Harbour east breakwater is an example of a breakwater that was damaged badly in a 2-year ARI storm in May 1997 when 20 units of 40t concrete blocks were displaced on the breakwater (Figure 10b) and after subsequent modelled repair strategies were utilised in 2001 and 2012 withstood the June 2016 storm with relatively minor damage (<1%). Figures 10c and 10d indicate the two Hanbar units that were displaced during the 2016 storm.

Figure 10a MHL physical modelling comparing Accropode, rock, Antifer cubes and Hanbars (MHL 1997)

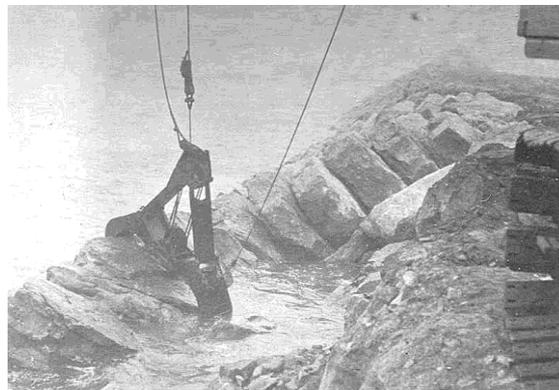
Figure 12b Special placement $K_d = 4-8$ (CERC)

- The NE-E direction of the storm resulted in extensive crest and head damage to the Clarence north training wall.
- In instances where severe head damage was observed such as Clarence north, Clarence south and Port Macquarie north training walls, rock placement (Figures 12b and 12c) with appropriate longer axis providing higher Kd values (>4) as utilised in CERC (1987) may have resulted in less damage.

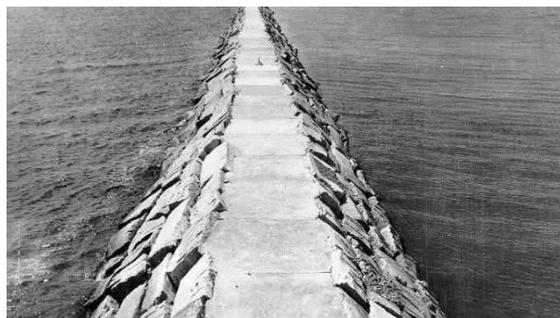
Figure 12c Special placement $K_d = 8-10$ (CERC)
