FROM SEA WALL TO SEA LIFE: IMPLEMENTING SEAWALLS THAT SUPPORT INTERTIDAL BIODIVERSITY

C Covich¹, P Makim²

Abstract

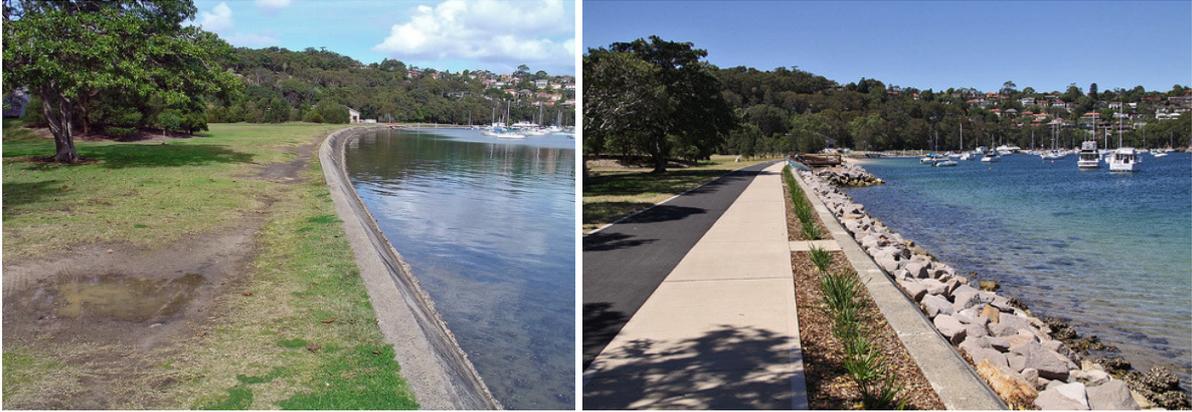
Figure 14 & 15: Pearl Bay, before and after seawall construction

In addition to the increased activity within the marine and intertidal area, the works also resulted in an increased usage by local residents. As seen in Figures 14 and 16 the shoreline was rarely used as a destination given its limited amenity and the salt water preventing the establishment of plants. The re-engineering of the wall transformed not only the life dynamic but the aesthetic nature of the area. The integration of a viewing deck along with items such as a footpath and cycleway, increased planting and sand nourishment provided a destination for people to enjoy the newly created environment. Council counts of pedestrian and cyclists show a substantial increase in visitors to the area.

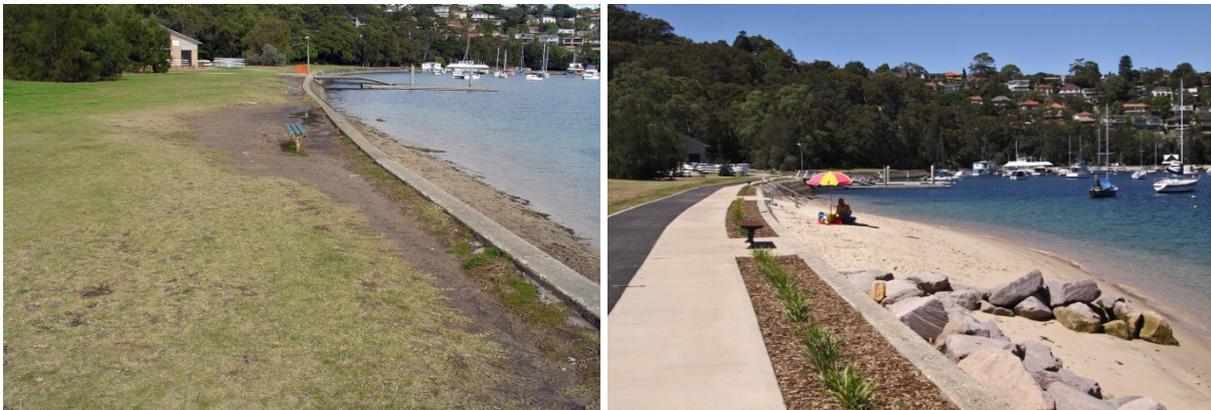
A viewing deck was installed over the saltmarsh planting area along with educational signage. Sand nourishment was undertaken on a beach area along with a pedestrian and bicycle path, seating and landscaping.

Figure 16 & 17: Pearl Bay, before and after beach reclamation

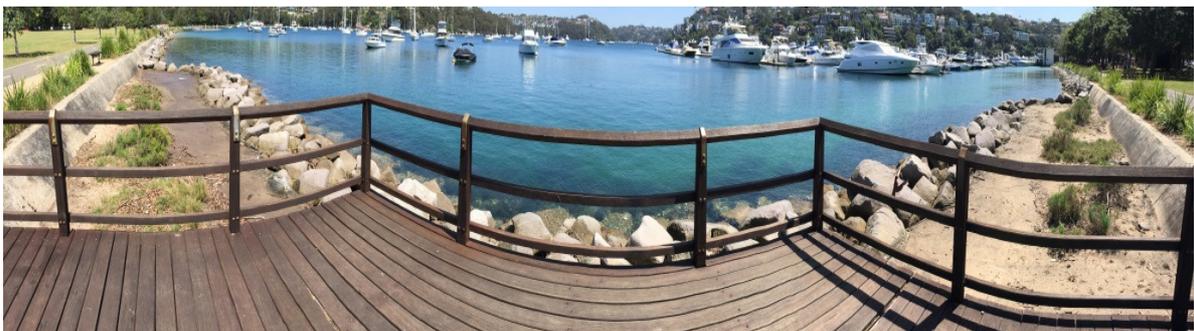
Figure 18: Viewing Deck at Pearl Bay

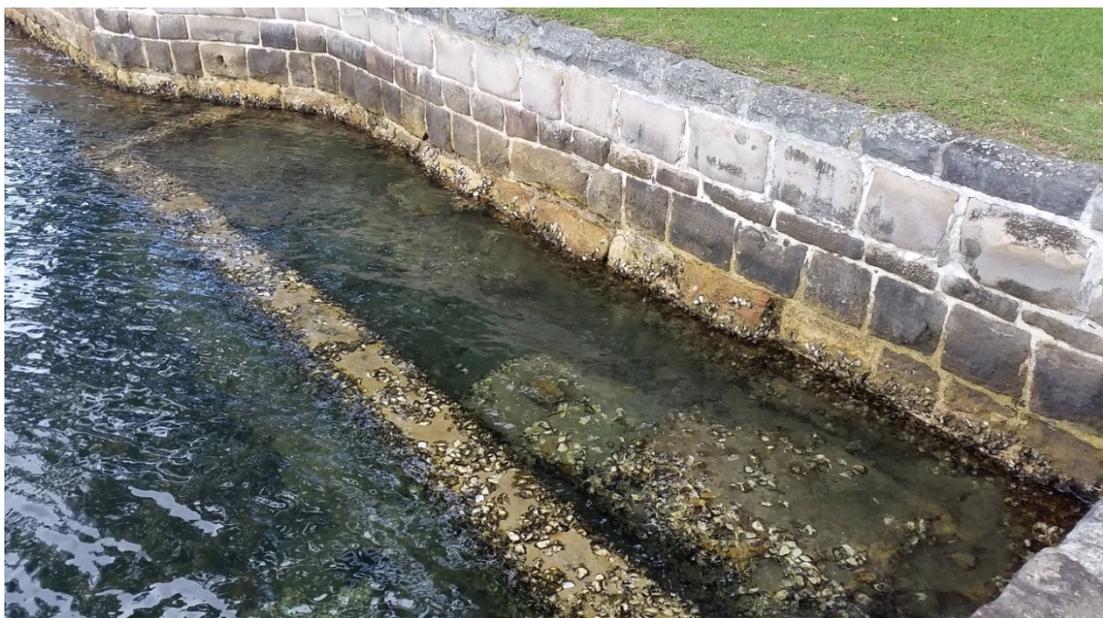
Works at this location involved structural repairs to the wall followed by the construction of a tidal pool. The tidal pool was created by installing a low wall then placing a layer of sandstone cobbles and boulders in the pool to introduce habitat complexity. The pool is approximately 500mm deep. Advice from Gee Chapman of Ecological Impacts of Coast Cities (EICC) indicated that the pool depth did not necessarily need to be at 500mm, it was more important to have tidal flushing and regular rubbish removal. As a result, the location of the pool relative to the tide was critical as was a cleaning regime. The construction cost approximately \$1100/m.

Figure 20: Tidal Pool at Pearl Bay West

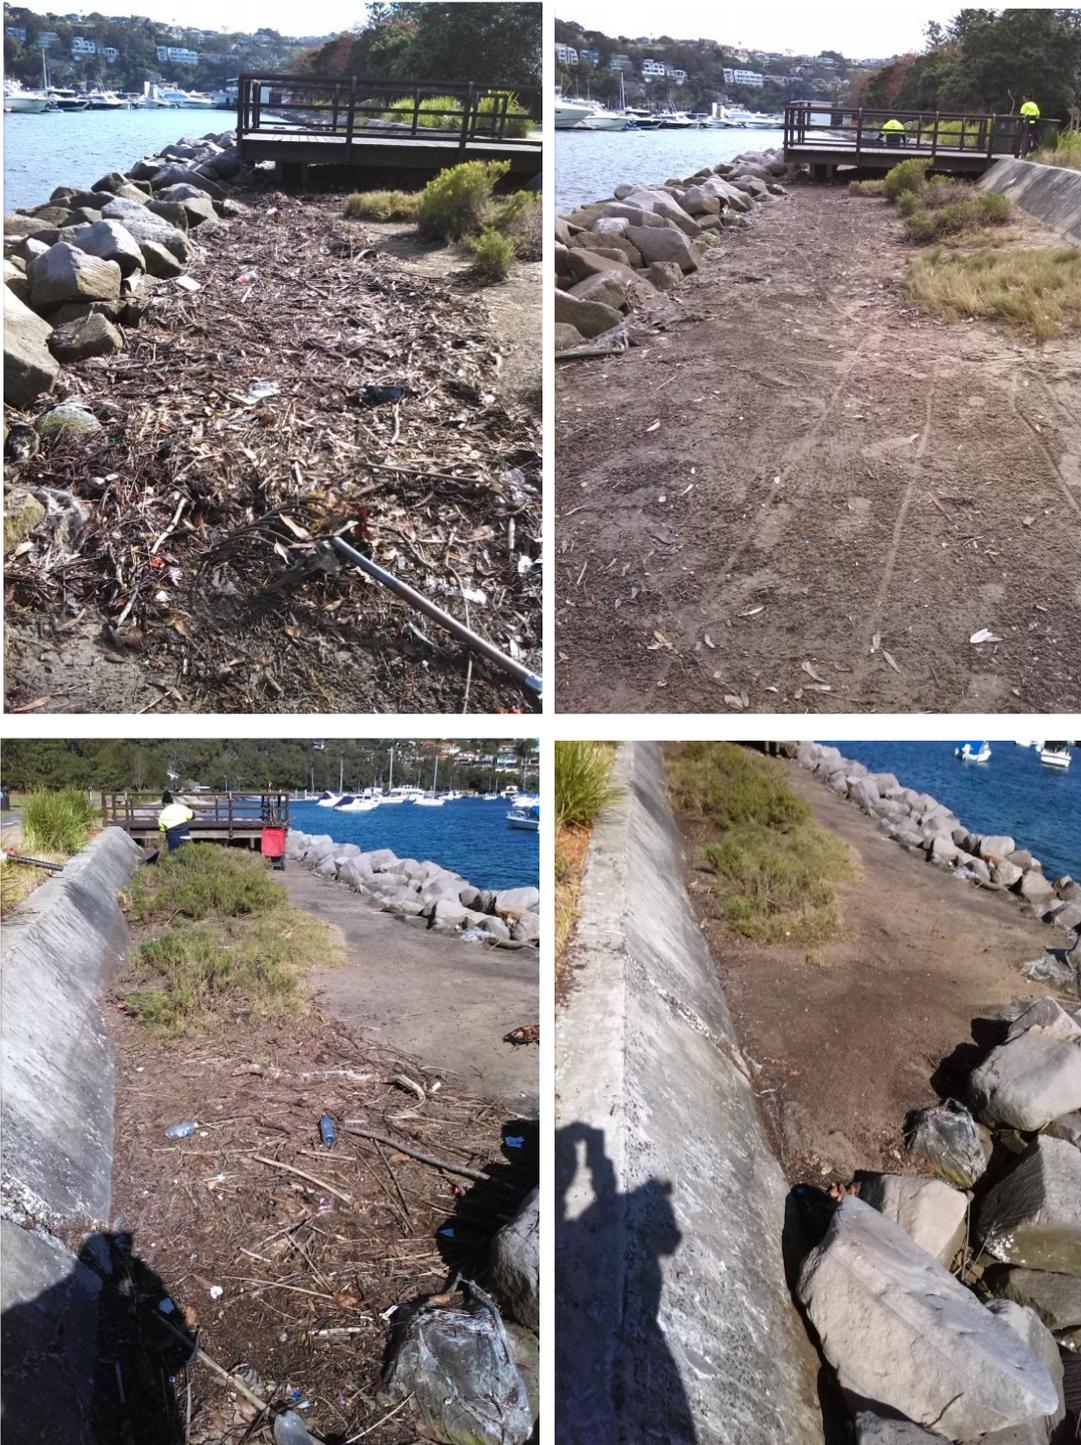
Whilst 90% of Mosman's stormwater network is treated by stormwater quality improvement devices (SQIDs) that collect gross pollutants, westerly winds transport floating debris and waste from neighbouring Council areas. Unfortunately these Councils did not have the same waste removal coverage for their catchments. The extent of the debris is seen in Figures 24 and 26.

Figure 24, 25, 26 & 27: Rubbish on the planting platform before and after, Pearl Bay
